# Sample survey report

## ANONYMISED EXAMPLE REPORT

A populated example of our Level 3 survey service.

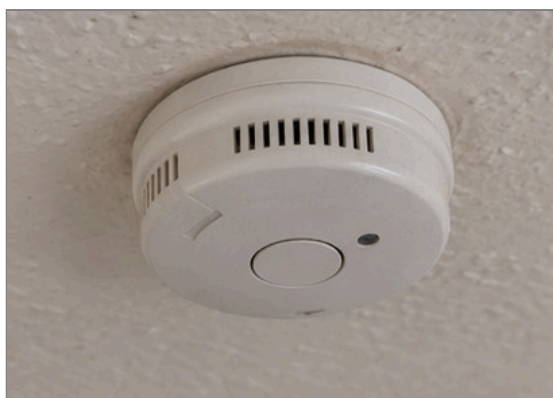
Battery-operated smoke alarms were fitted on the ground floor.

*Photo - 3 Typical fire alarm*

The smoke detection system is battery-operated. We recommend that the fire detection and alarm system be reviewed and, where necessary, upgraded to provide an appropriate level of protection in accordance with the relevant requirements of BS 5839. You should obtain advice from a suitably qualified fire alarm specialist regarding the appropriate system for the property and any necessary upgrades.

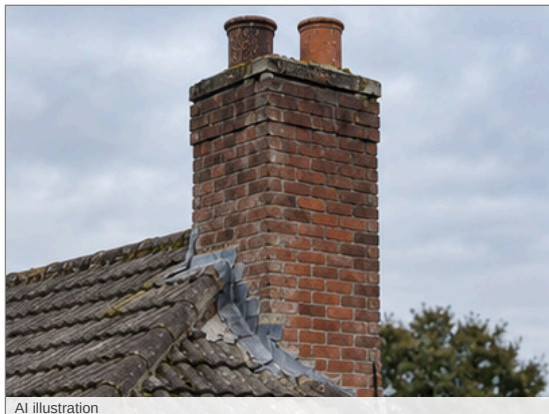
The rear right chimney stack is shared with the owner of the adjoining property. The ownership, maintenance responsibilities and rights relating to the shared stack should be confirmed by your legal adviser. Depending upon the nature and extent of any proposed works, the Party Wall etc. Act 1996 and/or other legal requirements may apply.

*Photo - 7 Rear-right chimney stack*

| Element | Repairs | Cost | Notes |
|---|---|---|---|
| D1 | Repair rear-right chimney flaunching and deteriorated masonry and pointing. Replace chimney pots if damaged during the work. | | |

Before undertaking any repair, alteration or removal works to the shared chimney stack, you should obtain appropriate legal advice and liaise with the adjoining owner to ensure that the necessary consents, notices or agreements are obtained where required.

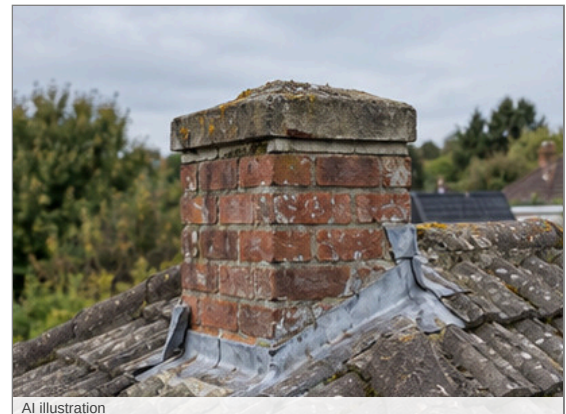
*Photo - 8 Rear-left chimney stack*

| Element | Repairs | Cost | Notes |
|---|---|---|---|
| D1 | Maintain chimney flashings and the reduced rear-left stack capping and masonry. Repair defective weathering and retain appropriate ventilation to redundant flues. | | |

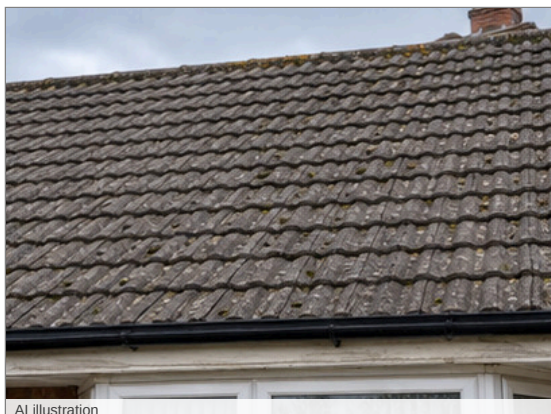
*Photo - 12 Front roof slope*

| Element | Repairs | Cost | Notes |
|---|---|---|---|
| D2 | Realign slipped roof tiles and renew defective fixings. Coordinate roof repairs with the roof structure assessment under E1. | | |

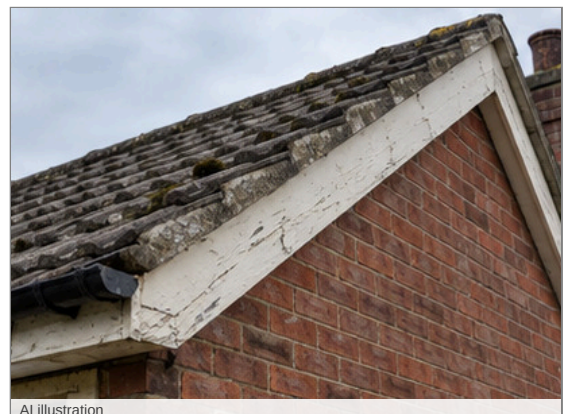
The main roof undercloak may contain asbestos-containing material (ACM). The material should not be disturbed, cut, drilled, sanded or otherwise damaged until its composition has been confirmed. Where works are proposed that may affect the material, appropriate asbestos testing and/or an asbestos survey should be undertaken by a suitably qualified asbestos professional.

*Photo - 13 Front left verge*

| Element | Repairs | Cost | Notes |
|---|---|---|---|
| D2 | Rebed or repoint defective ridge tiles and renew cracked and eroded verge mortar. | | |

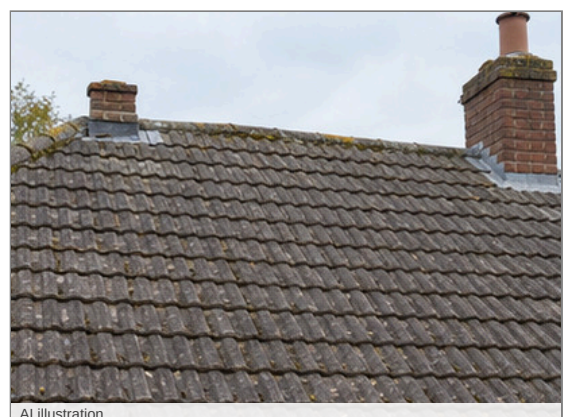
*Photo - 15 Rear roof slope*

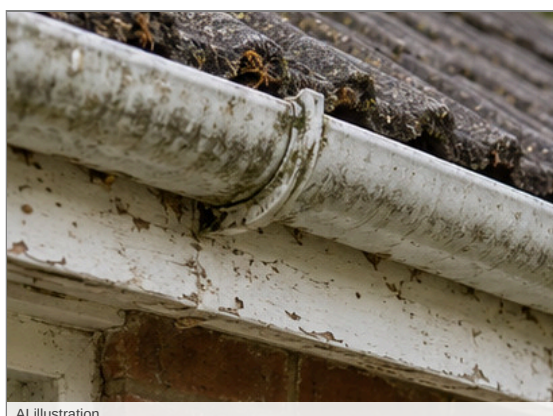
The rainwater gutters and downpipes are shared with the adjoining property. Your legal adviser should confirm your rights and obligations in relation to their ownership, maintenance, repair and replacement, together with any rights of access required to undertake future works.

*Photo - 21 Front gutter*

| Element | Repairs | Cost | Notes |
|---|---|---|---|
| D3 | Clear gutters and repair leaking joints. Correct falls and alignment to ensure effective discharge to downpipes. | | |

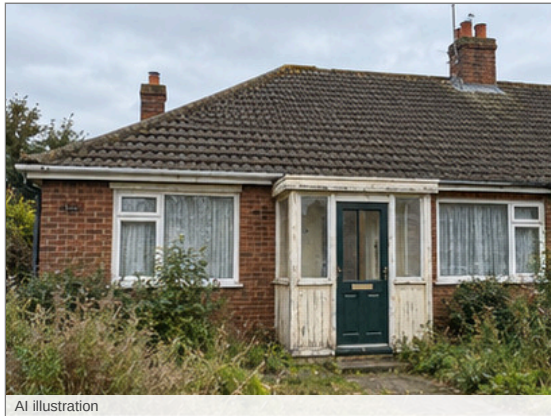
*Photo - 28 Front elevation*

between the DPC and adjoining external ground levels. We recommend that you budget for reducing the external ground level to provide an appropriate separation from the DPC and help maintain its effectiveness. The revised ground level should also provide suitable falls and drainage away from the building.

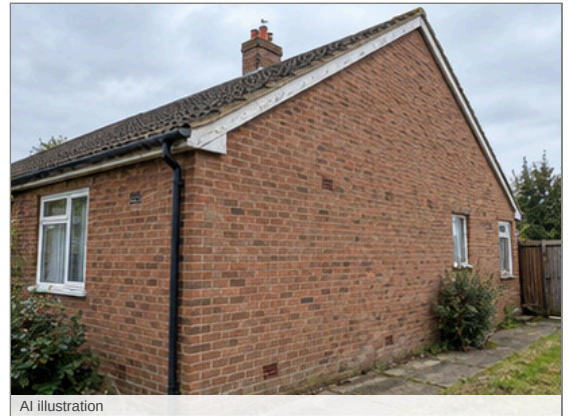
*Photo - 29 Left elevation*

| Element | Repairs | Cost | Notes |
|---|---|---|---|
| D4 | Remove vegetation from contact with the left-hand wall. Inspect exposed masonry and repair defective pointing or deterioration. | | |

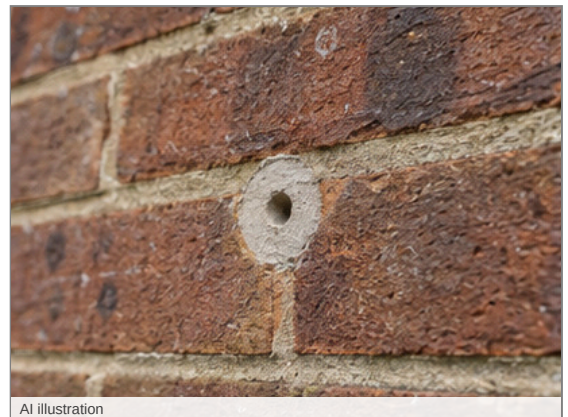
*Photo - 31 Evidence of injected insulation*

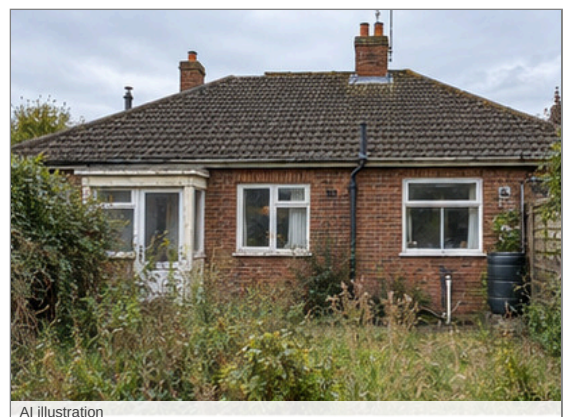
*Photo - 33 Rear elevation*

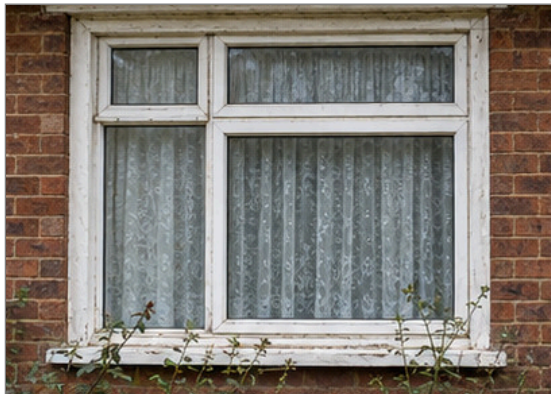
*Photo - 36 Front window*

Given the age, condition and limited thermal performance of the installation, replacement with a modern double-glazed window is recommended. The surrounding opening should be checked and made good as necessary when the works are undertaken.

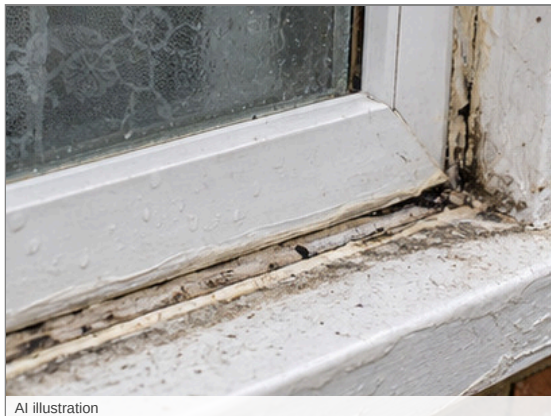
*Photo - 38 Replace sealant*

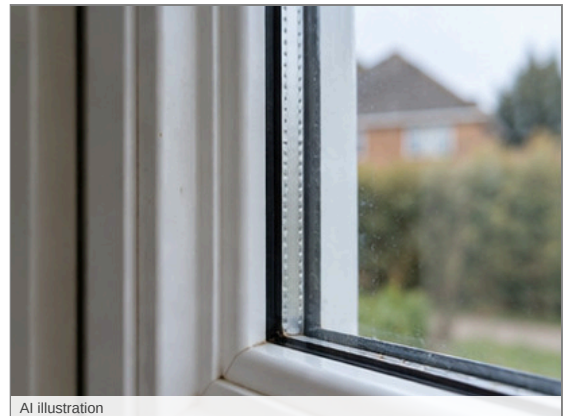
*Photo - 39 Thin double glazing*

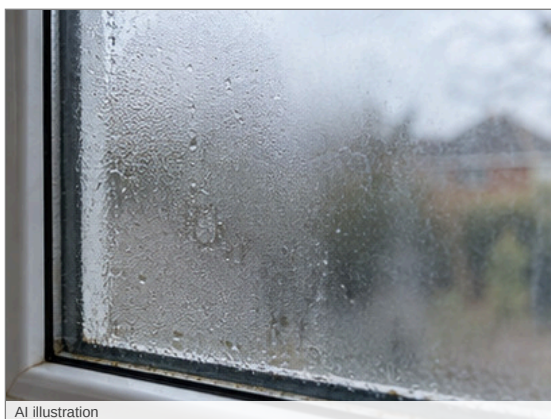
*Photo - 40 Failed double glazing*

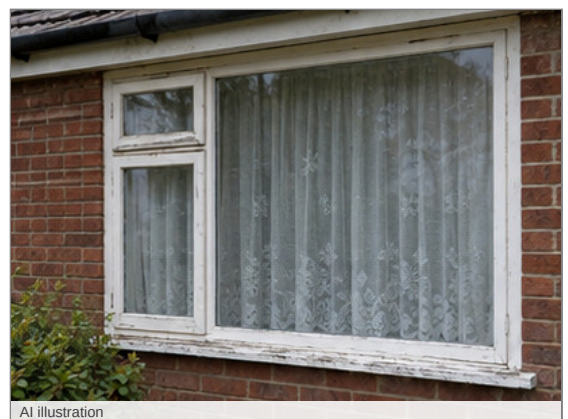
*Photo - 41 Left-hand window*

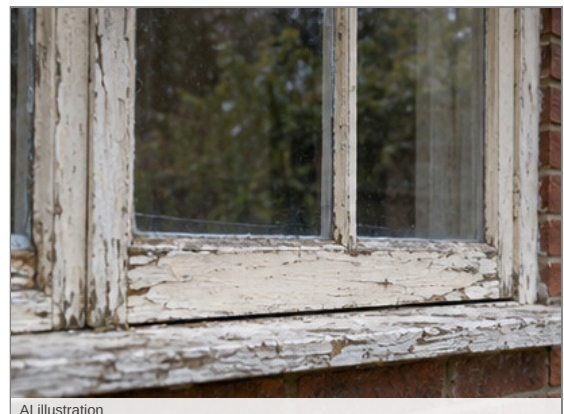
Photo - 45 Timber window

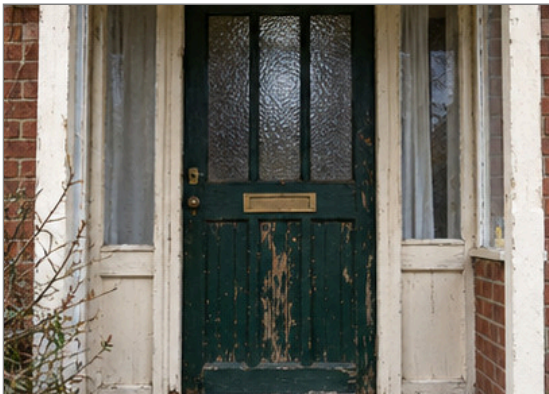
*Photo - 46 Front door*

| Element | Repairs | Cost | Notes |
|---|---|---|---|
| D6 | Replace the decayed main entrance door and frame with a suitable secure door assembly. Coordinate with porch replacement under D7. | | |

Replacement of the complete door assembly with a modern double-glazed unit incorporating compliant safety glazing and a modern secure locking system is recommended.

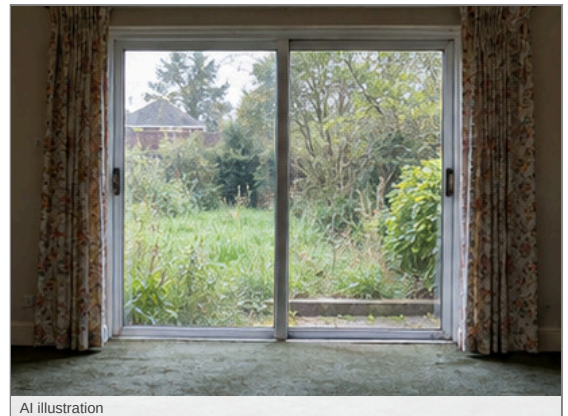
*Photo - 49 Rear sliding doors*

| Element | Repairs | Cost | Notes |
|---|---|---|---|
| D6 | Replace the dated rear sliding patio door and rear glazed door with modern secure assemblies incorporating suitable safety glazing. The rear glazed door could not be unlocked. | | |

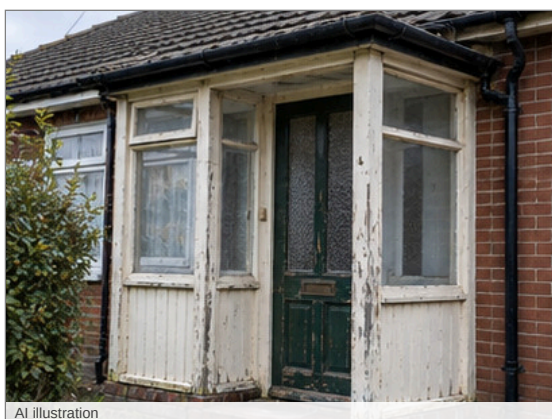
construction is approaching the end of its useful serviceable life and localised repairs are unlikely to provide a satisfactory long-term solution.

*Photo - 51 Porch*

| Element | Repairs | Cost | Notes |
|---|---|---|---|
| D7 | Replace the deteriorated timber-framed entrance porch. Inspect exposed supports and renew defective components. Coordinate associated door and window works to avoid duplication. | | |

We recommend that the porch be replaced rather than repaired. The replacement should incorporate suitably treated external-grade materials, appropriate weatherproof detailing and adequate separation from adjacent ground surfaces to reduce the risk of future moisture-related deterioration. The underlying supporting structure should also be inspected once the existing porch is removed and any defective or decayed components renewed as necessary. There is a porch to the front of the property. The porch appears to be a later addition to the property and comprises a pitched roof covered with concrete tiles. The porch has timber-framed walls with upvc cladding and a concrete floor.

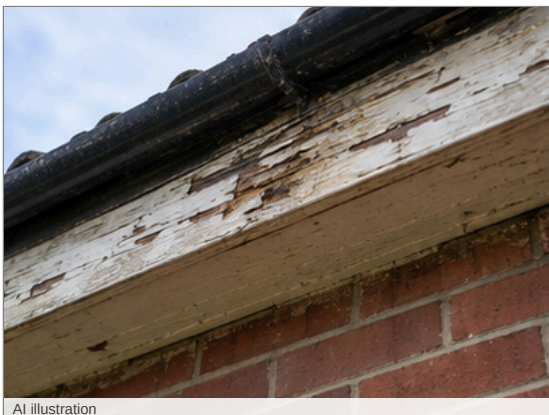
*Photo - 55 Front joinery*

| Element | Repairs | Cost | Notes |
|---|---|---|---|
| D8 | Repair or replace decayed timber roofline sections and redecorate. Repair defective uPVC roofline joints and fixings. Review roof ventilation with the associated roof works. | | |

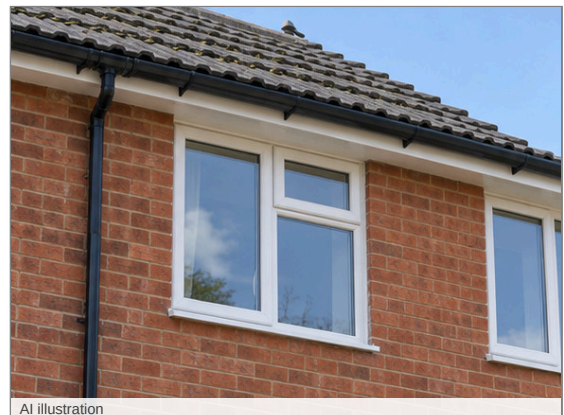
*Photo - 56 Left joinery (uPVC)*

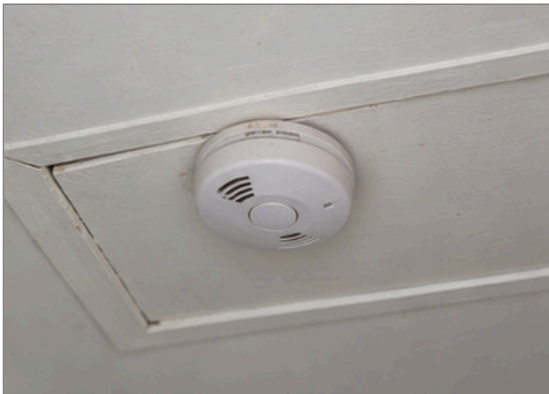
*Photo - 58 Fire alarm attached to loft hatch*

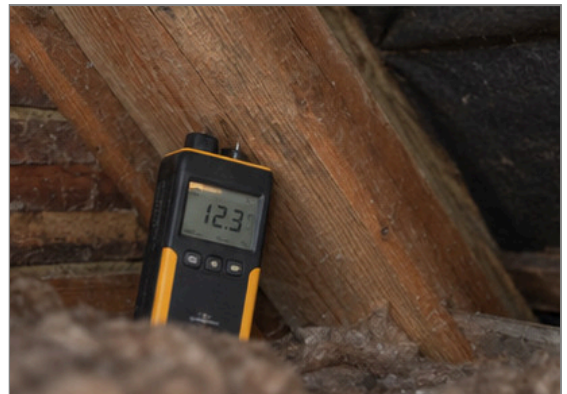
*Photo - 61 Front roof slope - low moisture reading*

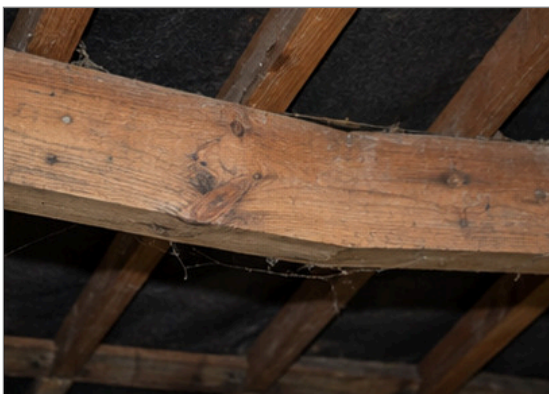
Of particular importance are the moderate deflection to the front and rear roof purlins, the outward movement identified to the lower rear elevation masonry, and the uncertainty regarding the rear-left chimney breast/flue arrangement, where the corresponding internal structure could not be clearly traced. These matters require further investigation, including structural advice where recommended, before legal commitment.

*Photo - 62 Front purlin - moderate deflection*

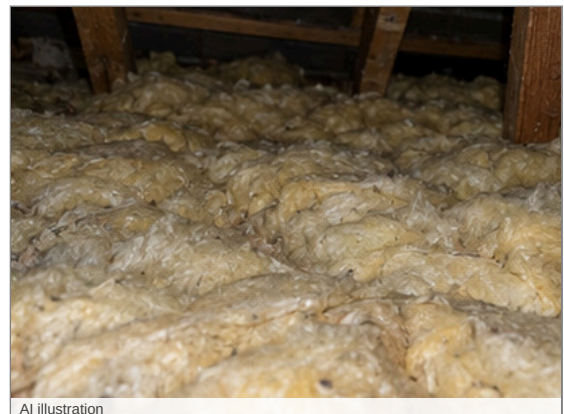
*Photo - 65 Insulation*

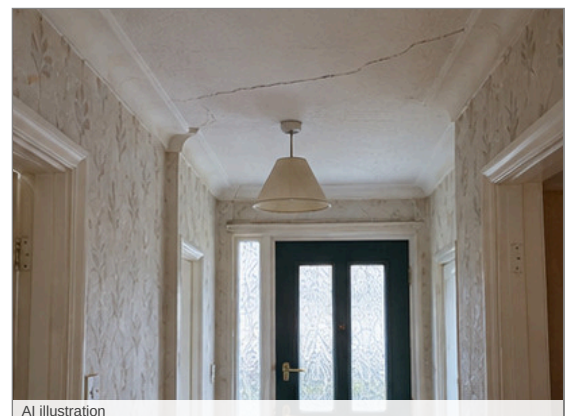
*Photo - 68 Entrance hall - minor fracture noted*

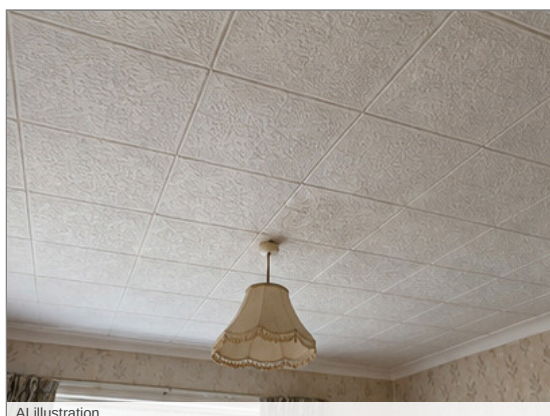
*Photo - 69 Living room - polystyrene tiles*

We recommend that the polystyrene products be removed immediately and replaced with a suitable non-combustible or appropriately fire-rated ceiling finish. Removal may damage the underlying ceiling or adhesive and could expose defects that are currently concealed. You should therefore allow for associated preparation, repair and making-good works following removal.

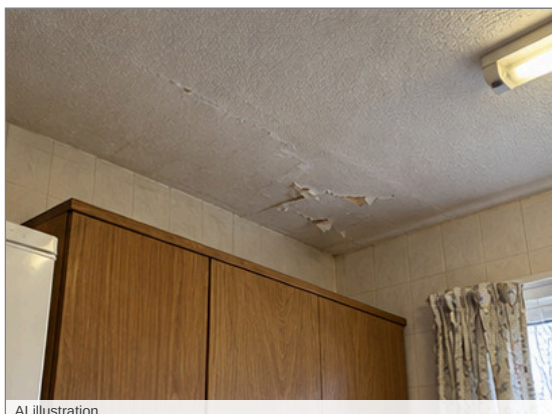
*Photo - 71 Kitchen - minor repair required*

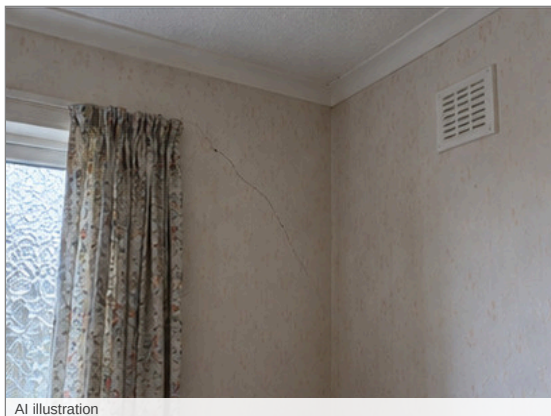
*Photo - 73 Front right bedroom - minor fracture noted under the window*

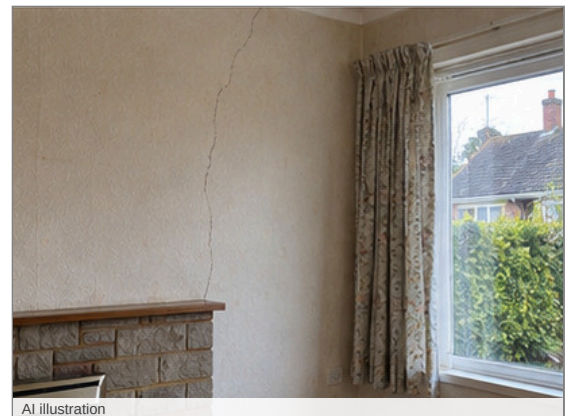
*Photo - 74 Living room front elevation - minor fractures noted*

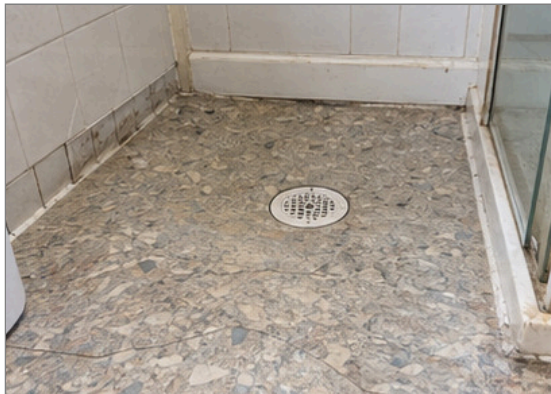
*Photo - 75 Shower room floor - potential asbestos containing material*

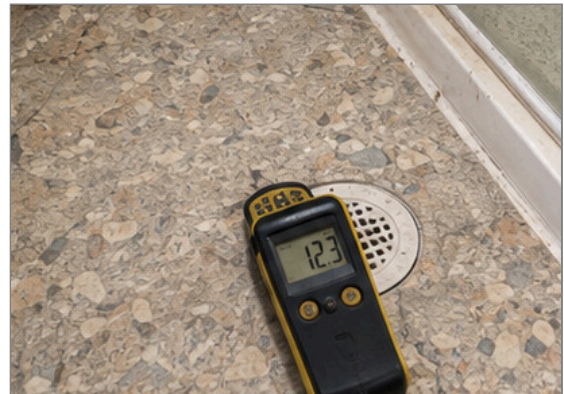
*Photo - 76 Shower room floor - low moisture reading*

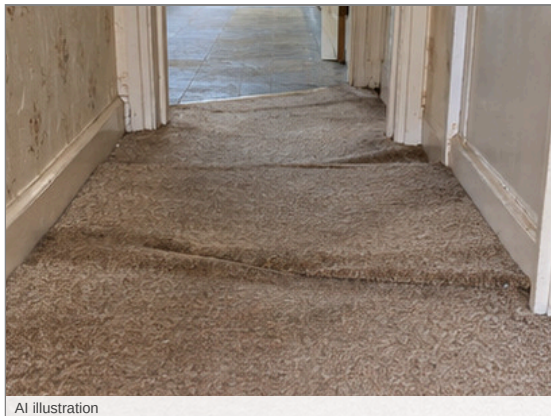
*Photo - 77 Entrance hall uneven floor*

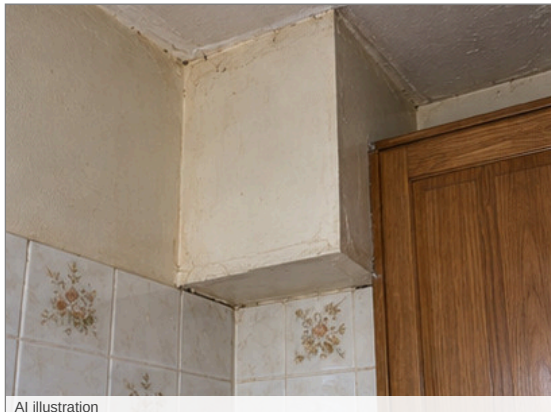
AI illustration  
Photo - 84 Possible termination point for the rear-left chimney stack

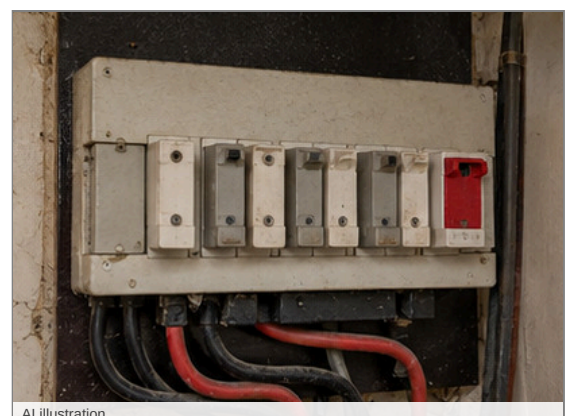
*Photo - 102 Distribution board*

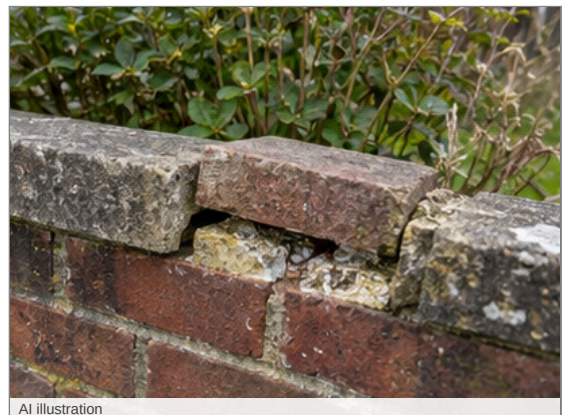
*Photo - 127 Loose masonry*

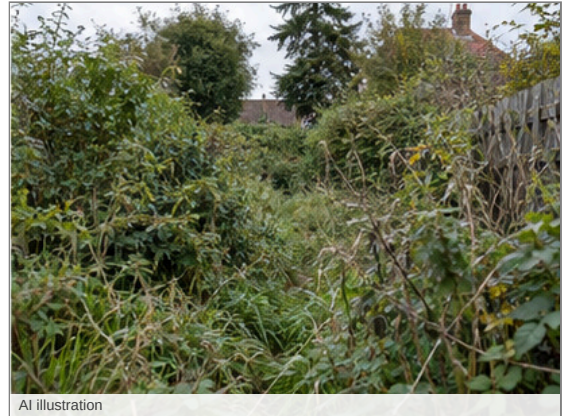
Externally, repairs are required to boundary masonry, drainage chamber benching, roofline components and other weathered finishes. The rear garden is heavily overgrown and could not be fully inspected, so additional defects may become apparent once the vegetation has been cleared.

*Photo - 131 Rear garden - no access*
