LEVEL 2

# Sample survey report

## ANONYMISED EXAMPLE REPORT

A populated example of our Level 2 survey service.

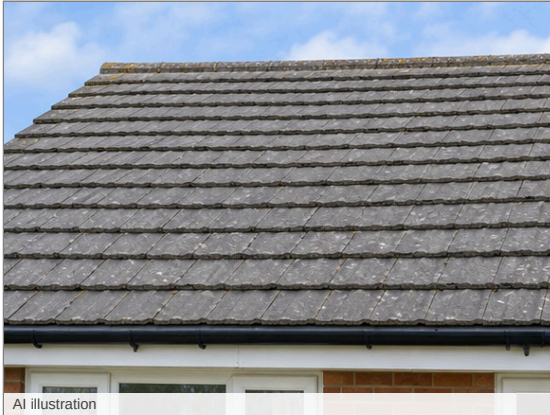
The roof covering is showing general age-related deterioration, including weathering and discolouration. Although the covering remains generally serviceable at present, further deterioration should be expected with age. The roof should be monitored and maintained regularly, with repairs undertaken as necessary.

*Photo - 5 Front roof slope*

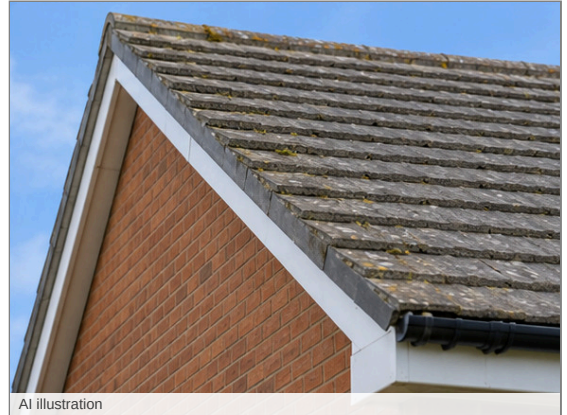
The tiles along the roof edges, technically known as the verges, are secured with mortar pointing. The mortar is starting to become weathered. Where the mortar is defective, we recommend that you budget for the affected verge pointing to be carefully removed and renewed using a suitable weather-resistant mortar system.

*Photo - 6 Front left verge*

The works should be undertaken as necessary to maintain the weather resistance of the roof edges and reduce the risk of water penetration into the roof structure and associated deterioration.

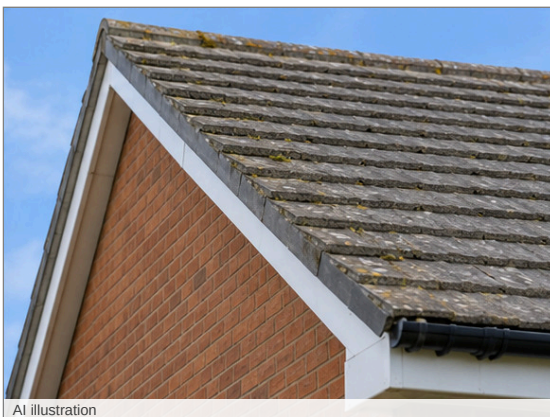
*Photo - 9 Left verge*

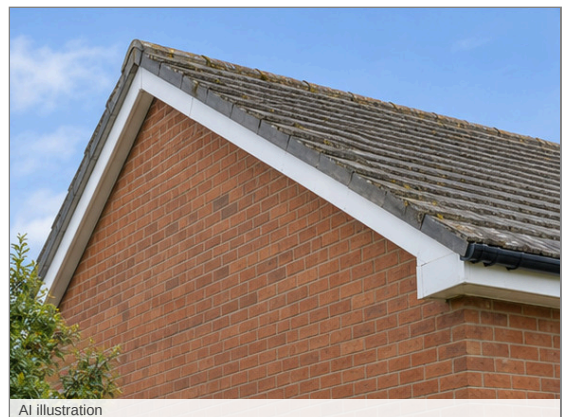
The main and main entrance roof undercloak may contain asbestos-containing material (ACM). The material should not be disturbed, cut, drilled, sanded or otherwise damaged until its composition has been confirmed. Where works are proposed that may affect the material, appropriate asbestos testing and/or an asbestos survey should be undertaken by a suitably qualified asbestos professional.

*Photo - 10 Undercloak - potential asbestos containing material*

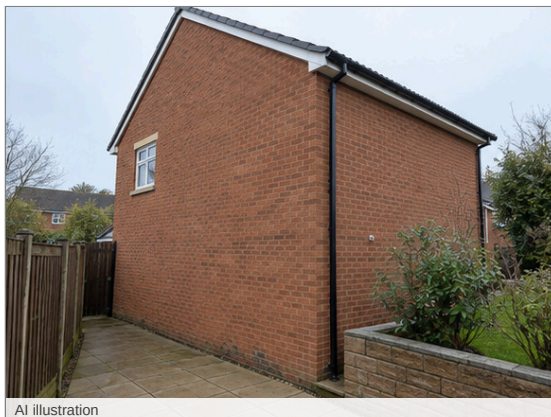
The external ground level is relatively high in relation to the damp-proof course on the front and rear elevation. A suitable gravel margin is provided adjacent to the building, which provides some separation between the external ground and the wall and assists with surface-water drainage.

The existing arrangement appears to reduce the risk of direct contact between the external ground and the wall; however, the relatively high ground level should be monitored, and the gravel margin kept clear to maintain effective drainage and prevent the accumulation of soil, vegetation or other debris against the building. No significant evidence of dampness attributable to the external ground level was identified at the time of our inspection.

*Photo - 22 Left elevation - high ground level*

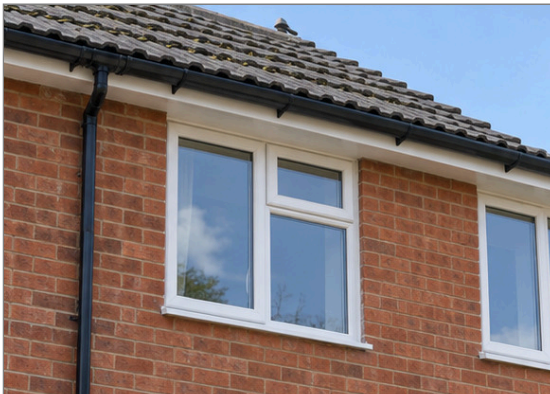
The roofline timbers are poorly decorated, with early stages of timber decay evident, particularly at the exposed edges. We recommend that you budget for the affected roofline timbers to be thoroughly prepared for redecoration, with decayed sections repaired or replaced as necessary. Following preparation and repair, the timber should be treated with a suitable preservative where appropriate and redecorated using a suitable primer, one coat of external-grade undercoat and two coats of external-grade topcoat, in accordance with the paint manufacturer's recommendations.

*Photo - 30 Front joinery*

In the longer term, you may wish to consider replacing the existing timber roofline components with a modern uPVC system. uPVC roofline products generally require less routine maintenance than painted timber and can provide good durability when appropriately specified and installed. The suitability and appearance of replacement uPVC should be considered in relation to the character of the property.

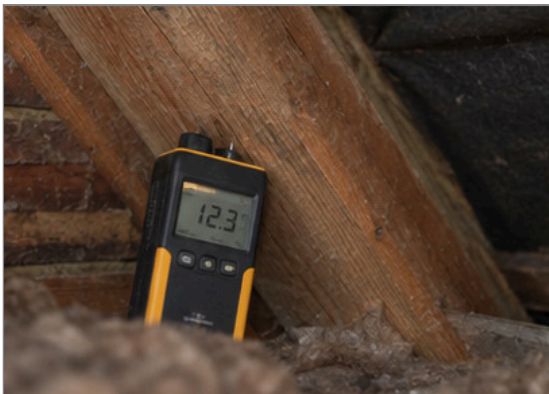
*Photo - 35 Front roof slope - low moisture reading*

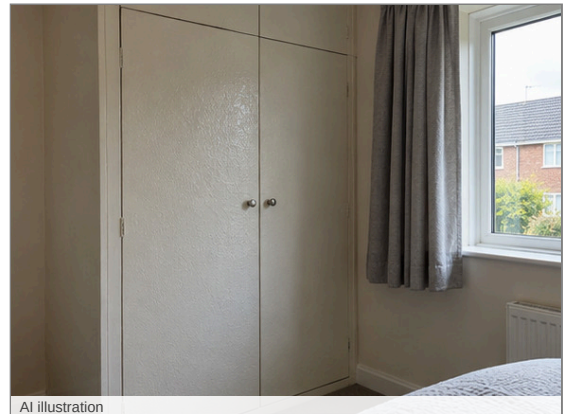
A textured decorative coating is present on the ceilings in the front bedroom cupboards and porch. Some older textured decorative coatings may contain asbestos-containing material (ACM). The presence or absence of asbestos cannot be confirmed by visual inspection alone.

*Photo - 40 Front bedroom cupboard - textured finish*

As a precaution, the textured coating should not be sanded, scraped, drilled, cut, removed or otherwise disturbed until its composition has been confirmed. Where future repair, alteration or removal works may disturb the coating, appropriate sampling and testing should be undertaken by a suitably qualified asbestos professional. Any works involving confirmed asbestos-containing material should then be carried out in accordance with the specialist's recommendations and applicable safety requirements.

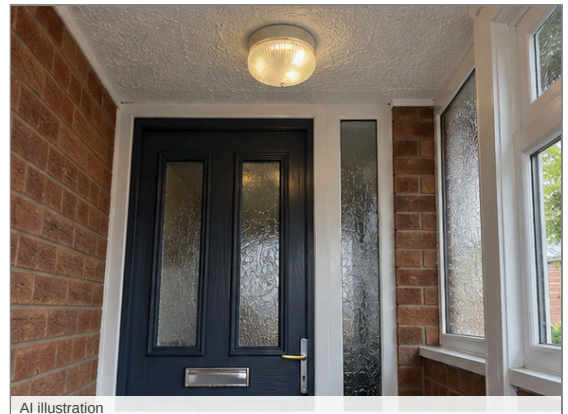
*Photo - 42 Porch - textured finish*

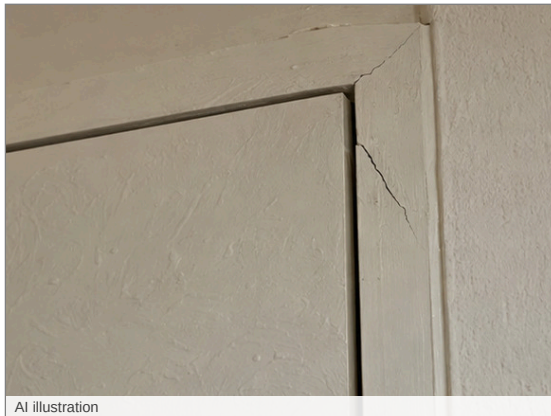
*Photo - 43 Front bedroom cupboard - minor fracture noted*

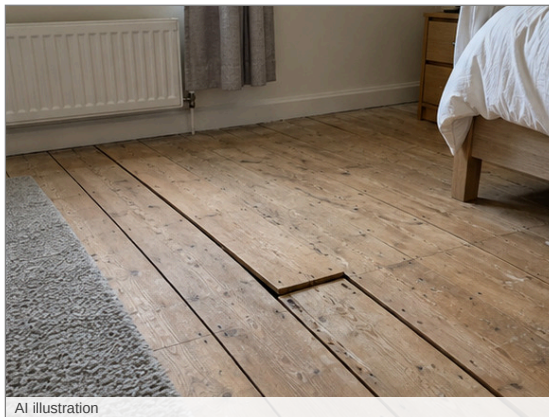
*Photo - 44 Rear bedroom - loose floorboards*

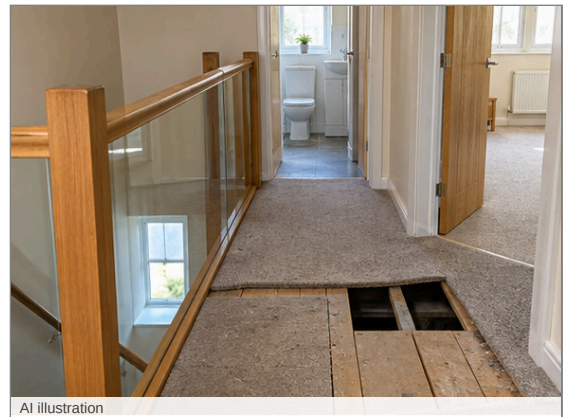
*Photo - 45 First floor landing - loose floorboards*

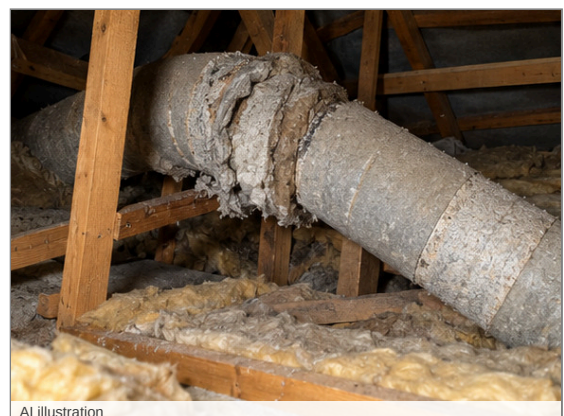
Photo - 46 Redundant flue

The redundant installation should remain undisturbed until it has been assessed by a suitably qualified asbestos surveyor. Sampling and laboratory analysis should be undertaken where necessary. Subject to the findings, redundant components should be safely removed and disposed of by an appropriately competent contractor. Any openings left following removal should be properly made good.

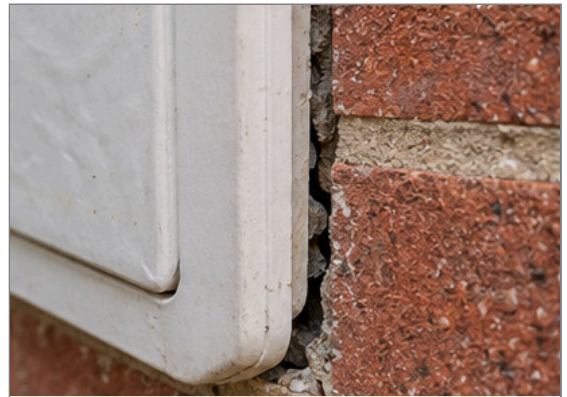
*Photo - 67 Sealant missing*

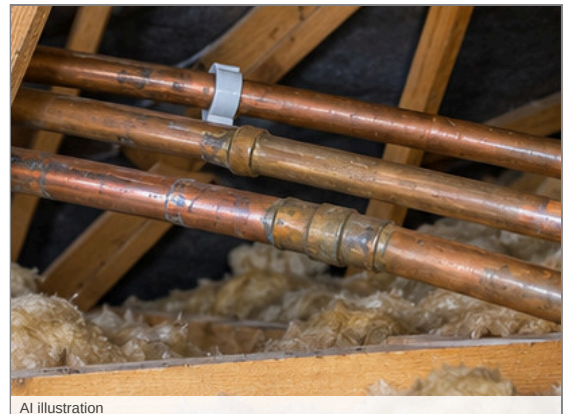
Photo - 84 Uninsulated water pipework in the loft

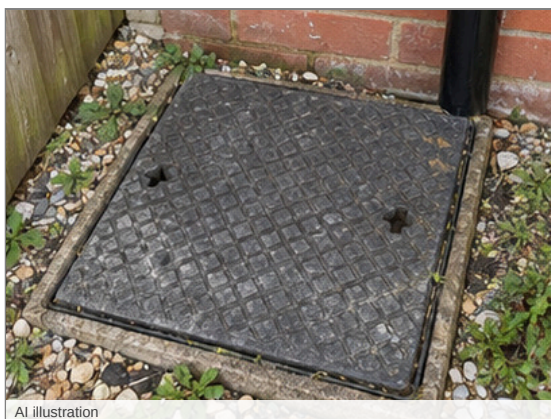
*Photo - 87 Rear inspection chamber - no access*

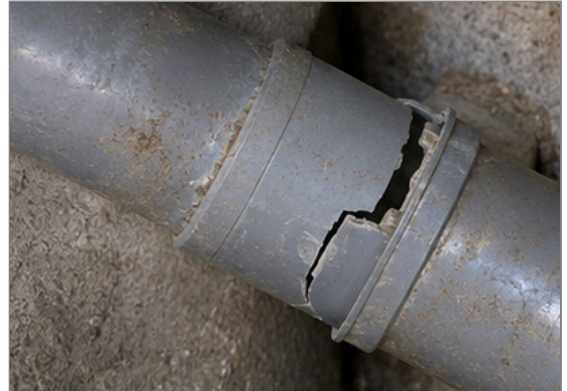
*Photo - 90 Broken pipe - replace*

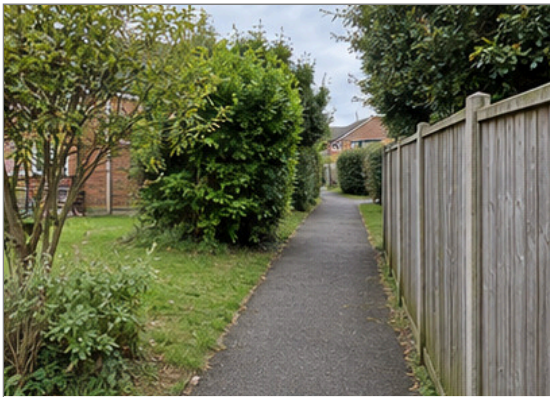
*Photo - 110 Possible public right of way*

Your legal adviser should confirm the ownership and position of the property boundaries, the extent of your legal responsibilities for their maintenance and repair, and any associated rights, obligations or restrictions.
