# Sample survey report

## ANONYMISED EXAMPLE REPORT

A populated example of our Level 3 survey service.

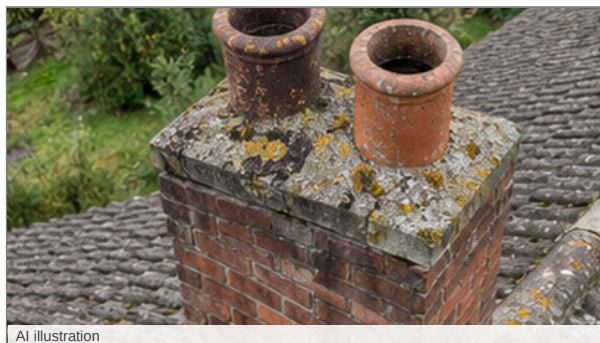
*Photo - 9 Rear-right chimney stack - drone view*

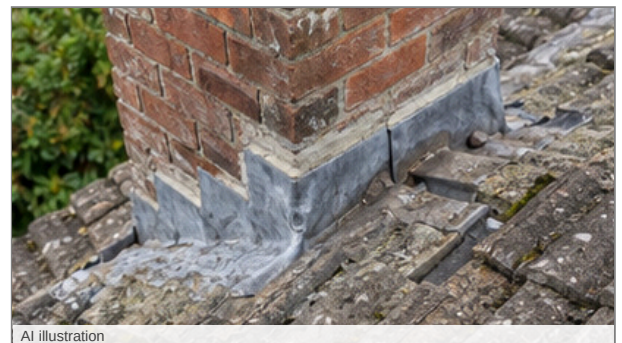
*Photo - 10 Rear-right chimney stack - drone view*

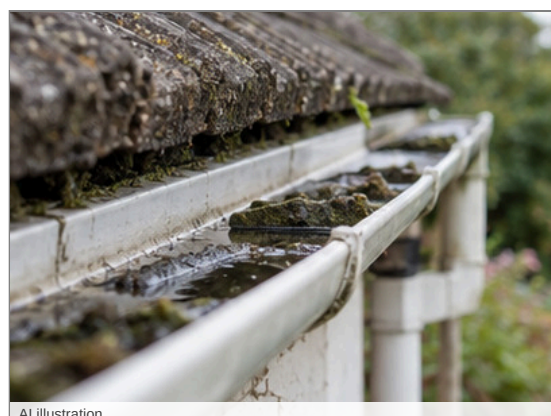
*Photo - 22 Incorrect falls*

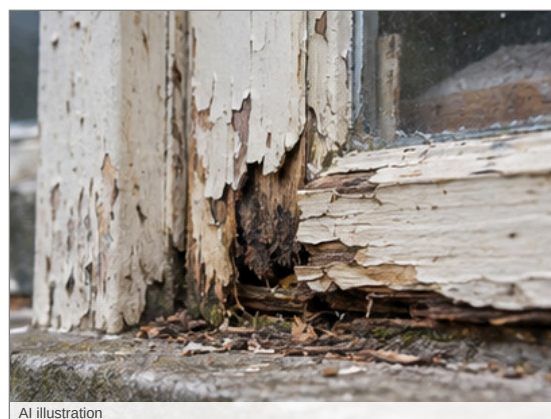
The timber-framed entrance porch is in poor condition and replacement is recommended. Several windows and external doors are also dated, with extensive repairs required in places, relatively thin or single glazing, and concerns regarding safety glazing and security. In our opinion, replacement of a number of these components is likely to be more economical than extensive repair.

*Photo - 52 Rotten frame*

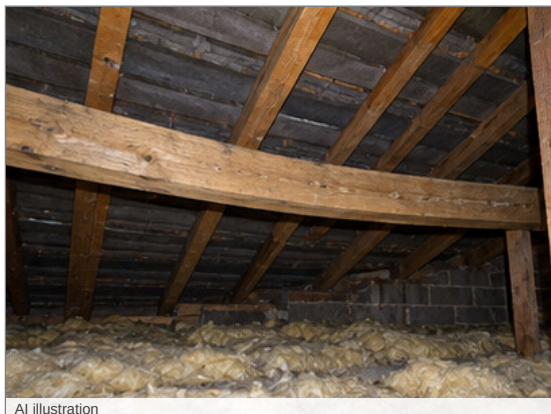
Of particular importance are the moderate deflection to the front and rear roof purlins, the outward movement identified to the lower rear elevation masonry, and the uncertainty regarding the rear-left chimney breast/flue arrangement, where the corresponding internal structure could not be clearly traced. These matters require further investigation, including structural advice where recommended, before legal commitment.

*Photo - 64 Rear purlin - moderate deflection*

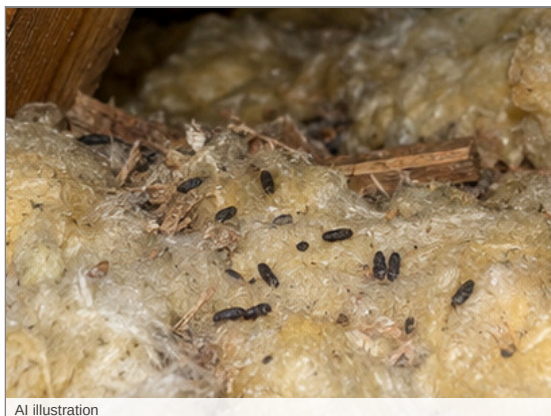
*Photo - 66 Evidence of rodent activity*

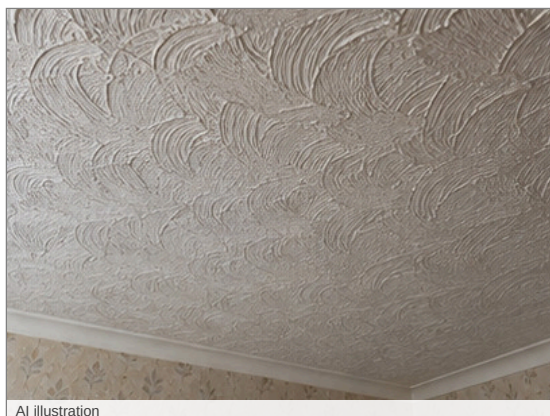
*Photo - 67 Typical textured ceiling*

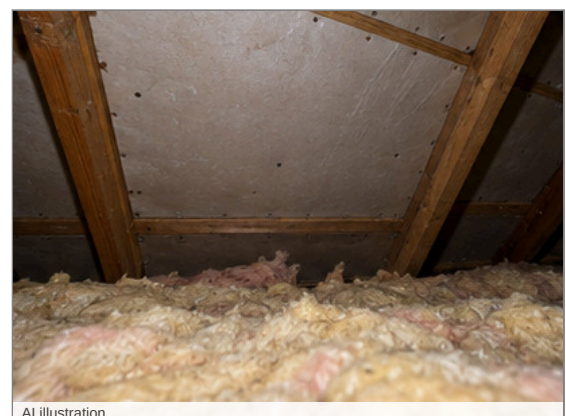
*Photo - 70 Plasterboard visible in the loft*

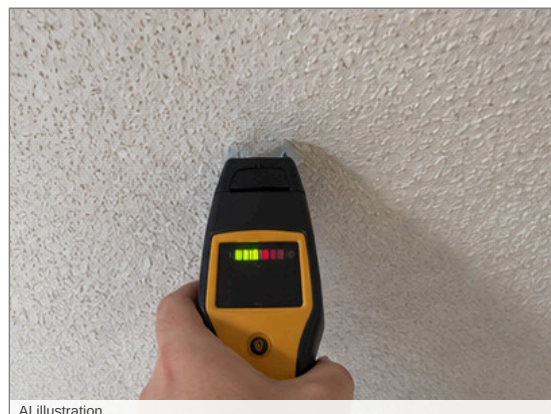
*Photo - 72 Low moisture reading*

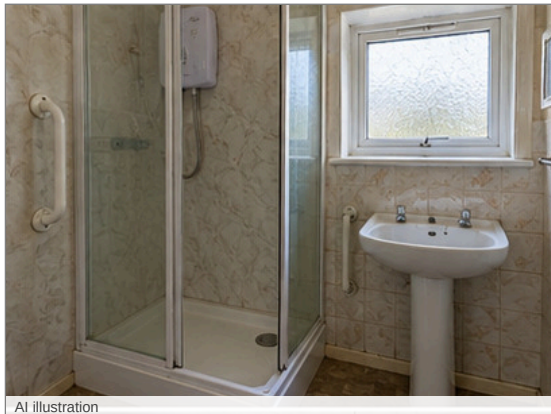
The sanitary fittings in the shower room comprise a shower with a glazed screen, a wash hand basin with a vanity unit and a toilet with a close-coupled cistern. The sanitary fittings appeared to be worn and showing general deterioration at the time of our inspection. We recommend the fittings be replaced once you take occupation.

Photo - 94 Shower room

Adequate ventilation is important in these areas to remove moisture generated by bathing and showering and to reduce the risk of condensation and mould growth. We recommend that suitable mechanical extract ventilation is installed, where practicable, to discharge moist air to the external environment. The ventilation should be appropriately designed, sized and installed in accordance with the manufacturer's requirements and applicable Building Regulations.

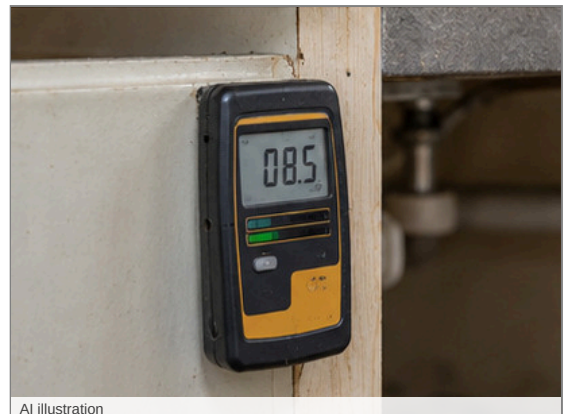
*Photo - 109 Low moisture reading*

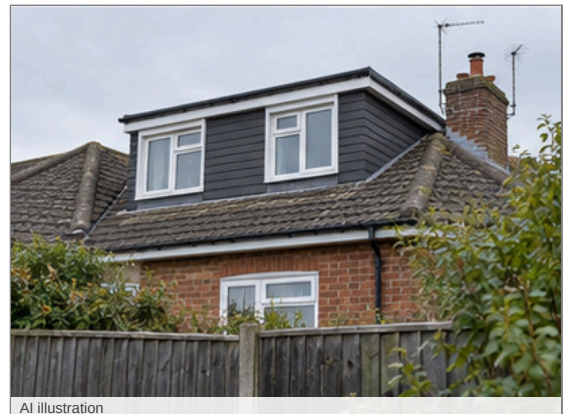
*Photo - 133 Neighbours loft conversion*

The adjoining property has been extended into the roof space to form a loft conversion, with a dormer structure constructed close to the party wall. Such works may have involved alterations to the shared wall, roof structure and associated supports.

Your legal adviser should confirm whether the works were carried out with the necessary Building Regulations approval and whether any Party Wall etc. Act 1996 procedures or agreements were required and completed. Any documentation relating to the loft conversion and works affecting the party wall should be obtained and reviewed before legal commitment.
