LEVEL 2

# Sample survey report

## ANONYMISED EXAMPLE REPORT

A populated example of our Level 2 survey service.

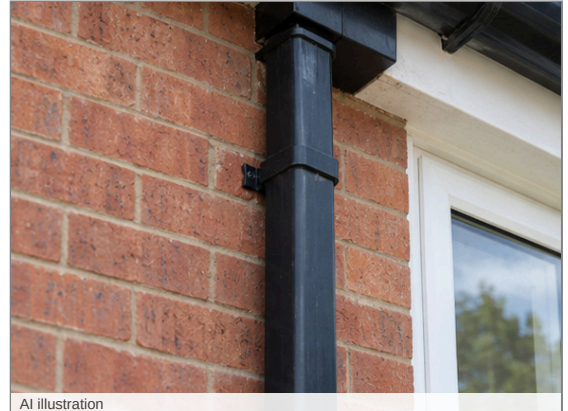
*Photo - 13 Front right downpipe - shared*

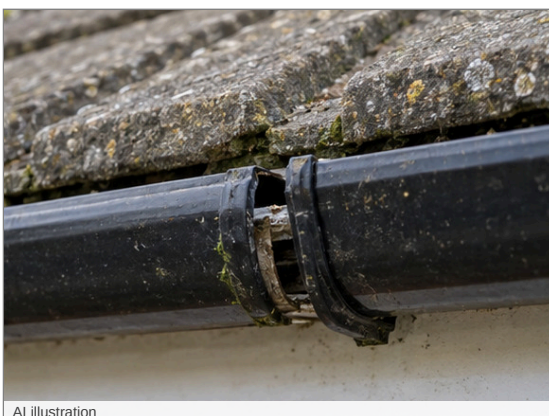
*Photo - 16 Open joint*

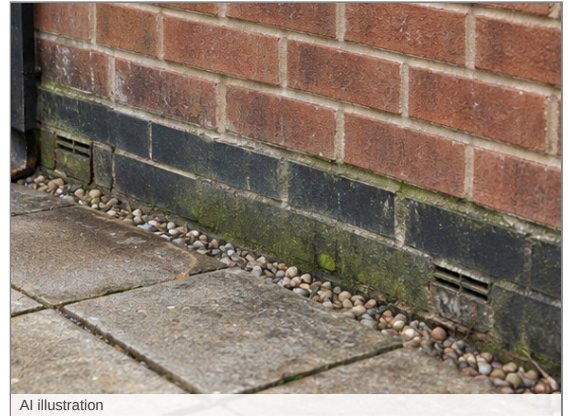
The external ground level is relatively high in relation to the damp-proof course on the front and rear elevation. A suitable gravel margin is provided adjacent to the building, which provides some separation between the external ground and the wall and assists with surface-water drainage.

*Photo - 21 Damp proof course*

The existing arrangement appears to reduce the risk of direct contact between the external ground and the wall; however, the relatively high ground level should be monitored, and the gravel margin kept clear to maintain effective drainage and prevent the accumulation of soil, vegetation or other debris against the building. No significant evidence of dampness attributable to the external ground level was identified at the time of our inspection.

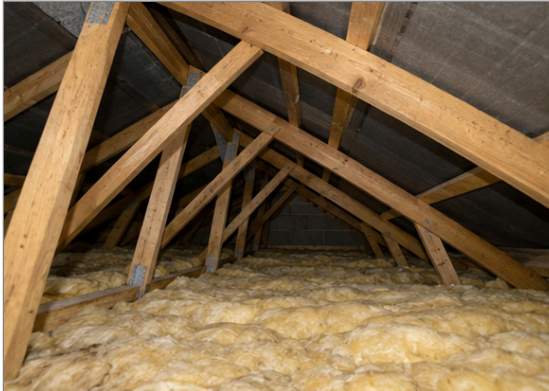
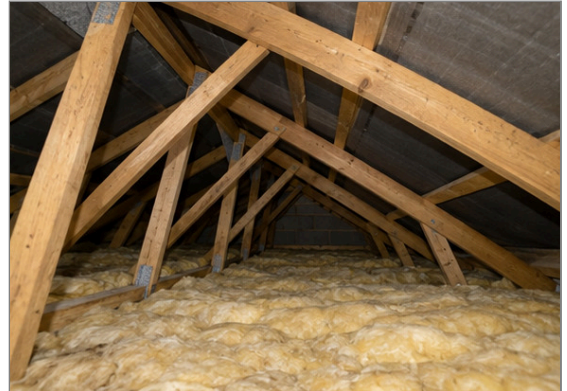
The secondary weathering membrane is suspected of containing asbestos. The presence or absence of asbestos cannot be confirmed by visual inspection alone.

As a precaution, the material should not be cut, drilled, sanded, broken, removed or otherwise disturbed until its composition has been confirmed. Where repair, alteration or removal works are proposed that may disturb the material, appropriate sampling and testing should be undertaken by a suitably qualified asbestos professional. Any works involving confirmed asbestos-containing material should then be carried out in accordance with the specialist's recommendations and applicable safety requirements.

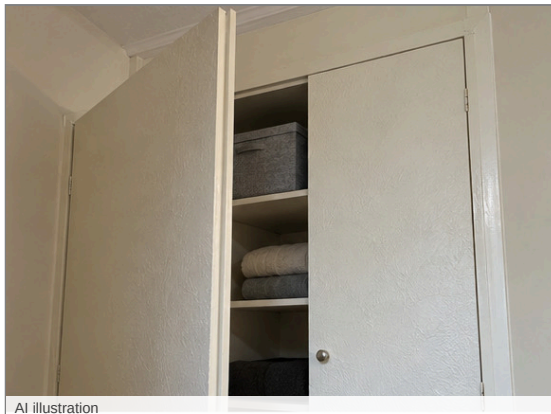
*Photo - 41 Front bedroom cupboard 2*

A textured decorative coating is present on the ceilings in the front bedroom cupboards and porch. Some older textured decorative coatings may contain asbestos-containing material (ACM). The presence or absence of asbestos cannot be confirmed by visual inspection alone.

As a precaution, the textured coating should not be sanded, scraped, drilled, cut, removed or otherwise disturbed until its composition has been confirmed. Where future repair, alteration or removal works may disturb the coating, appropriate sampling and testing should be undertaken by a suitably qualified asbestos professional. Any works involving confirmed asbestos-containing material should then be carried out in accordance with the specialist's recommendations and applicable safety requirements.

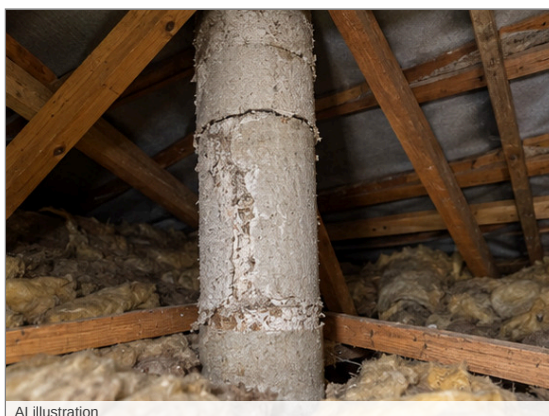
Photo - 46 Redundant flue

The redundant installation should remain undisturbed until it has been assessed by a suitably qualified asbestos surveyor. Sampling and laboratory analysis should be undertaken where necessary. Subject to the findings, redundant components should be safely removed and disposed of by an appropriately competent contractor. Any openings left following removal should be properly made good.

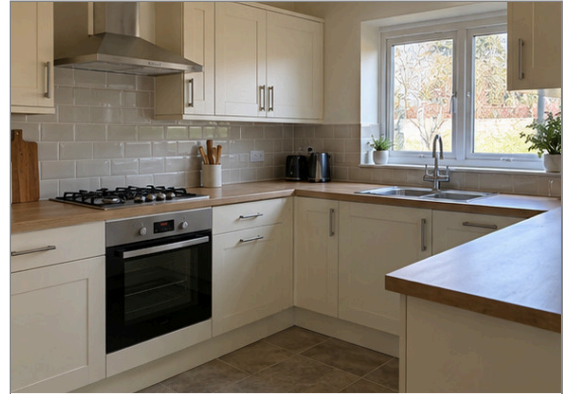
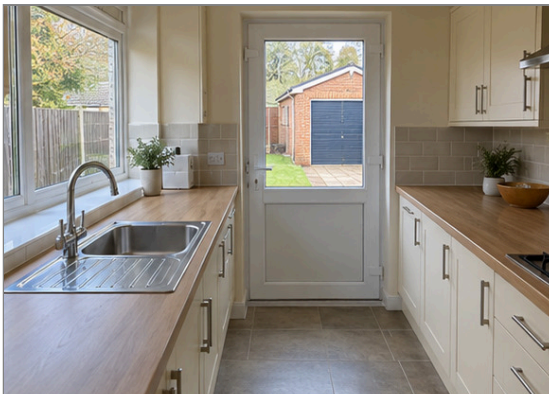
*Photo - 49 Kitchen*

Fixed kitchen/utility room units and appliances restricted inspection of the wall and floor surfaces behind and beneath them. Concealed areas may contain defects such as dampness, staining, leaking pipework, damaged finishes or deterioration to the unit carcassing.

The condition of these concealed areas could not be confirmed by visual inspection. Where the units or appliances are removed during future refurbishment, the concealed areas should be inspected, and any defects identified should be addressed as necessary.

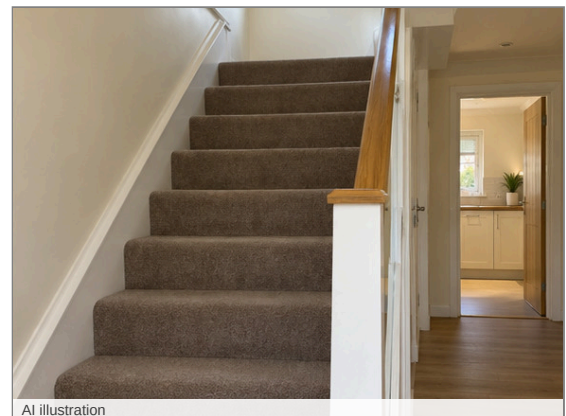
*Photo - 54 Staircase*

Condition rating 3

Your legal adviser should also confirm that the staircase alterations received any necessary Building Regulations approval and obtain the associated completion documentation.

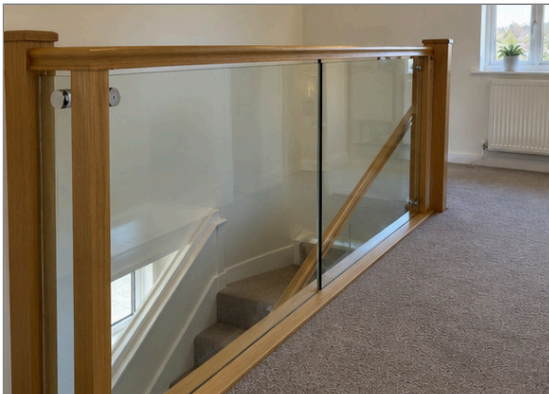
*Photo - 55 Glazed staircase*

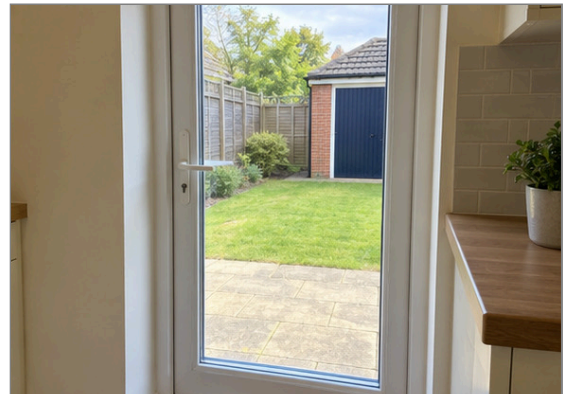
*Photo - 56 Glazed door*

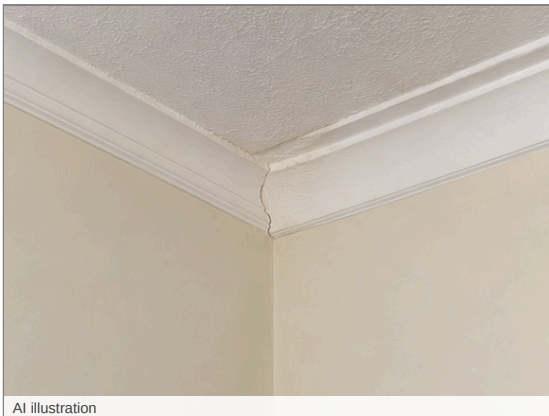
*Photo - 57 Coving*

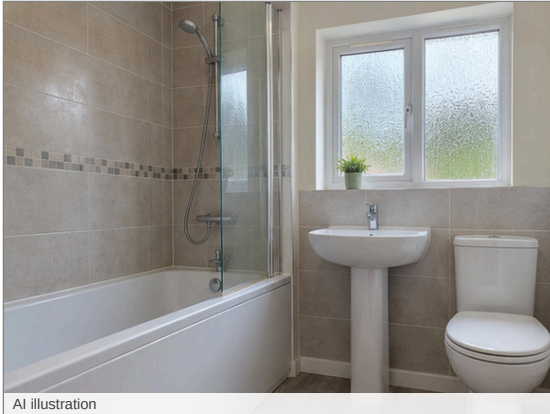
The accessible bathroom wall, ceiling and floor surfaces were tested using an electronic moisture meter where practicable. The readings were generally within the expected range for the materials tested at the time of our inspection.

*Photo - 58 Bathroom*

Adequate ventilation is important in these areas to remove moisture generated by bathing and showering and to reduce the risk of condensation and mould growth. We recommend that suitable mechanical extract ventilation is installed, where practicable, to discharge moist air to the external environment. The ventilation should be appropriately designed, sized and installed in accordance with the manufacturer's requirements and applicable Building Regulations.

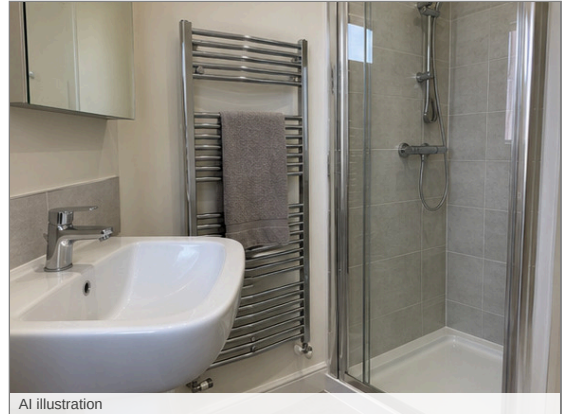
*Photo - 59 Bathroom*

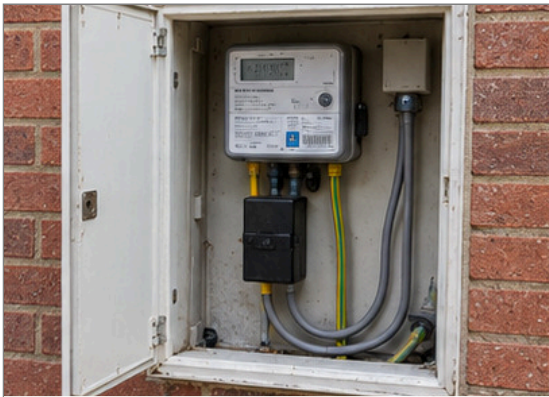
*Photo - 66 Incoming main and meter*

Therefore, I would recommend that a full electrical test and report be undertaken before a legal commitment to purchase the property to determine the cost and extent of any remedial works required for the system. Therefore, you are advised to instruct an NICEIC registered electrician to undertake an electrical test and report on the system.

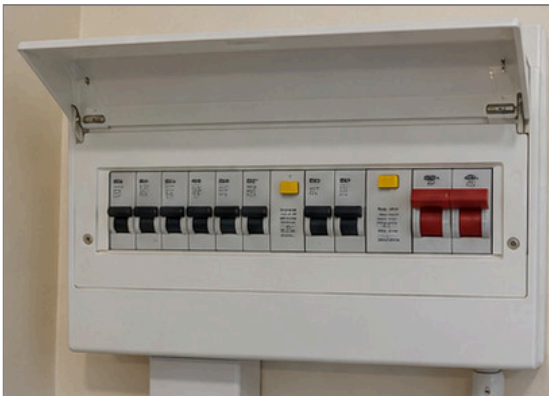
*Photo - 68 Distribution board*

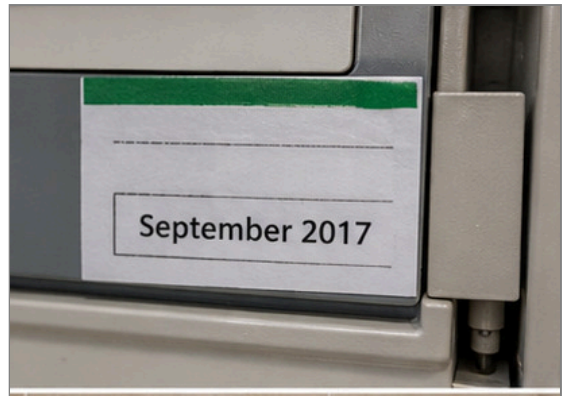
*Photo - 69 Tested September 2017*

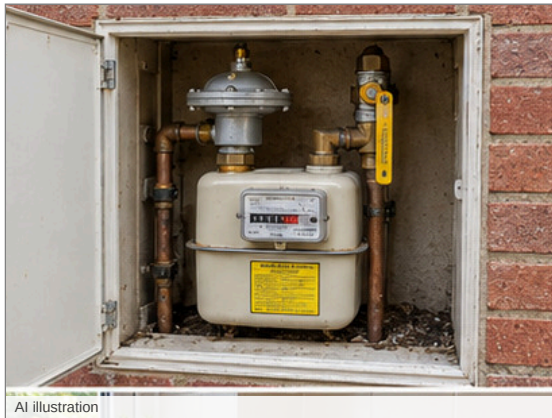
During my inspection, I was only able to make a superficial examination of the pipework, but from their appearance, I am satisfied they are in reasonable condition. It is nevertheless recommended that you obtain a copy of a GasSafe™ certificate from the vendor.

*Photo - 70 Gas meter and shut off valve*

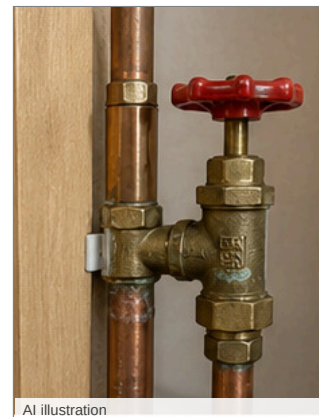
The internal stop valve is a brass-type valve. Such valves can become difficult to operate or seize with age, particularly where they have not been operated periodically. At the time of inspection, the valve was seized. Repair is recommended. Where replacement is required, a modern quarter-turn lever-type valve should be considered.

*Photo - 76 Internal stop valve*

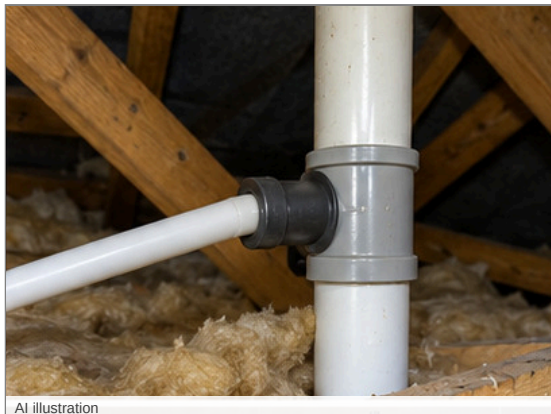
The boiler condensate discharge is connected into the internal drainage pipework within the roof space. This type of arrangement is acceptable in principle, provided the condensate connection is correctly formed and appropriately trapped. No evidence of leakage was identified at the time of inspection.

Photo - 83 Boiler condensate connected to soil vent pipe

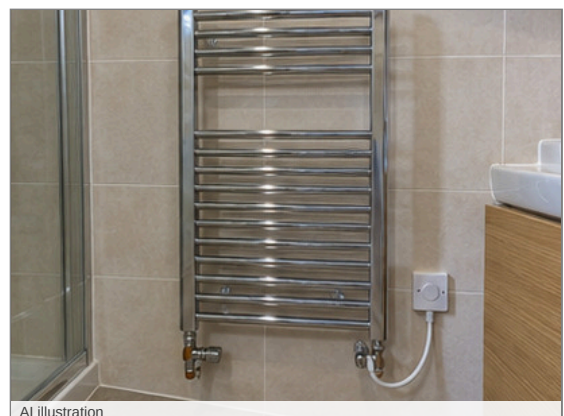
The bathroom towel radiator is connected to the central-heating pipework and also incorporates an electrical heating element. This dual-fuel arrangement allows the radiator to be heated independently of the central-heating system. The installation was not functionally tested, and the electrical connection should form part of the electrical installation inspection. No obvious leakage was identified at the time of inspection.

Photo - 86 Bathroom heater

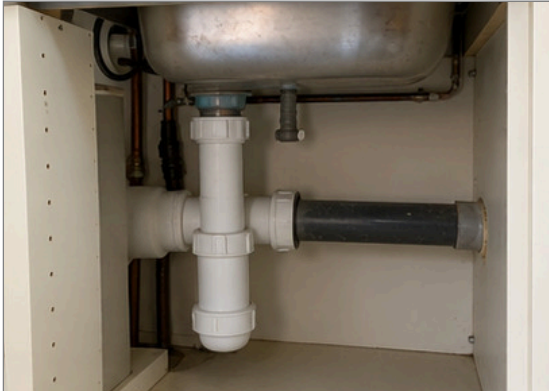
Where visible, the sanitary appliances within the property are connected to plastic waste pipes and traps. The external pipework was noted to be in a weathered and broken condition. The external pipework should be replaced soon, as appropriate.

*Photo - 89 Kitchen - external waste*

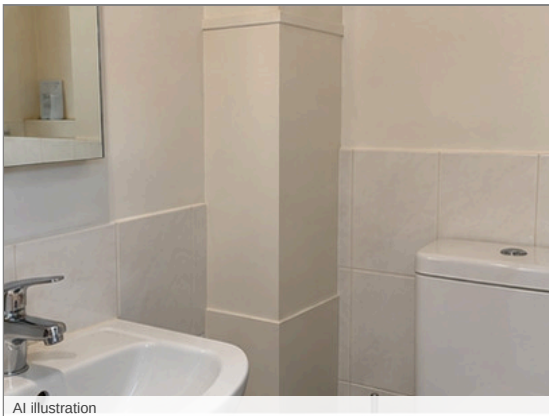
*Photo - 91 Soil pipe concealed in the bathroom*

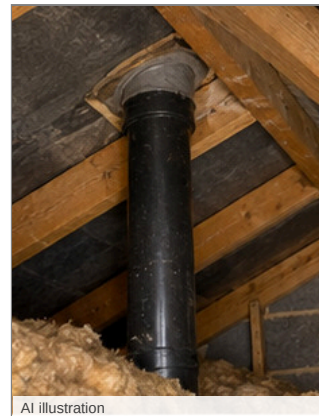
The drainage ventilation pipework within the roof space reduces to a relatively small diameter. This may form the ventilating section of the drainage system rather than the principal soil discharge stack and, in itself, is not necessarily defective. The concealed arrangement and connections below could not be fully established during the inspection. No evidence of leakage, foul odours or other drainage malfunction was identified at the time of inspection.

*Photo - 92 Soil vent pipe visible in the loft*

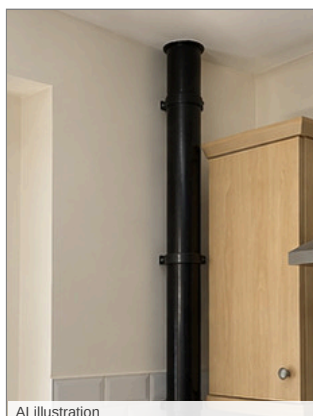
*Photo - 93 Soil vent pipe visible in the kitchen*

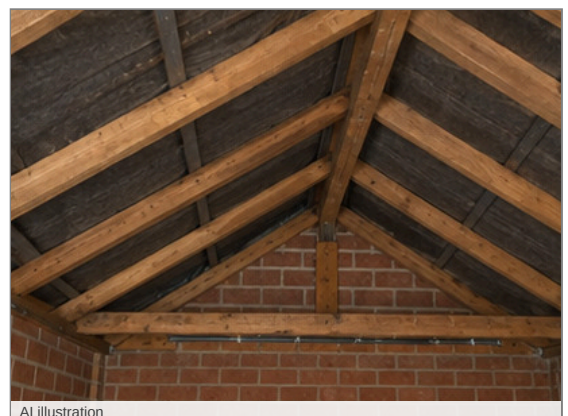
The garage roof covering is considered to be in average condition. Ridge repointing and verge repointing are recommended.

*Photo - 97 Roof structure*

The recommended works should be undertaken within years 1-3 to maintain the weatherproof integrity of the roof and reduce the risk of water penetration and consequential damage to the underlying roof structure and internal finishes.

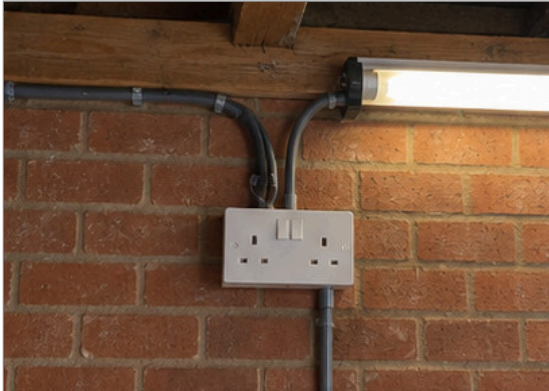
*Photo - 98 Electrical installation*

The garage is provided with electrical power and lighting. These installations were not tested as part of our inspection. We recommend that the garage electrical installation be inspected and tested by a suitably qualified electrical contractor, either as part of the property's electrical installation condition report (EICR) or by separate testing where appropriate. Any defects identified should be rectified as necessary.

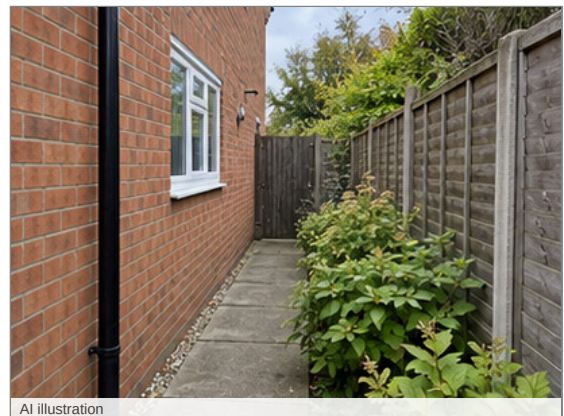
*Photo - 102 Rear left boundary*

The boundaries to the rear of the property generally consist of timber fence panels. These were generally noted to be in satisfactory condition at the time of our inspection.

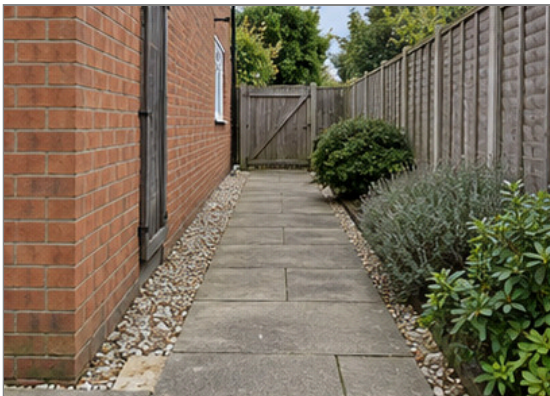
*Photo - 107 Path*

There is a section of paved path to the front of the property. The surface was uneven and weathered at the time of our inspection. The surface should be repaired and professionally cleaned within six months.

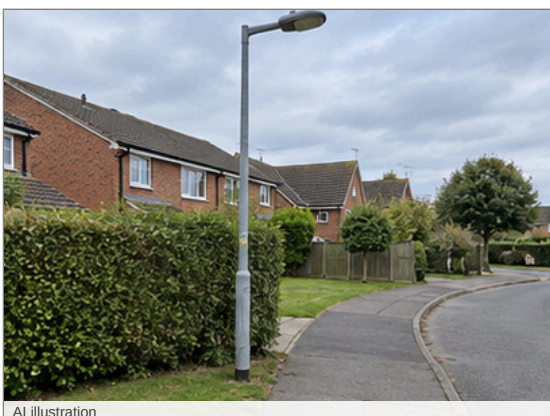
A street lighting column is positioned close to the side elevation of the property. Its proximity should be noted, as illumination from the lamp may be visible from windows and could cause some light intrusion during hours of darkness. No obvious physical effect on the property was identified at the time of inspection.

*Photo - 109 Street lamp in close proximity*

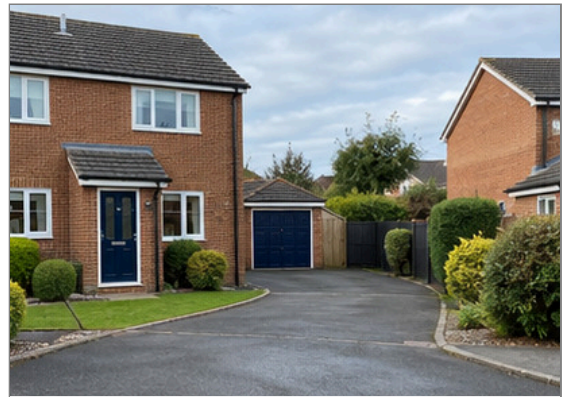
Access to the garage is through a possible private road that is not maintained by the local council. The road was in fair condition at the inspection. Your legal advisor should confirm this and advise you about the implications. The responsibility for private roads is usually shared between the people that use them.

*Photo - 111 possible private road*

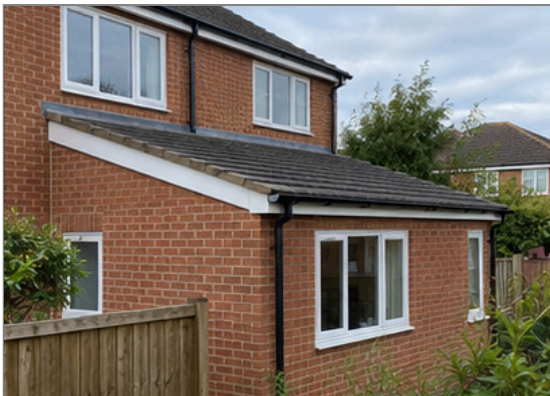
A single-storey extension to the neighbouring property has been constructed on or immediately adjacent to the shared boundary. The extension appears to form part of the boundary enclosure in this location. Your legal adviser should confirm the precise boundary position and establish whether any relevant Party Wall agreement, rights of access for inspection and maintenance, or other associated rights and obligations exist. No significant defects affecting the subject property were apparent from our visual inspection.

*Photo - 112 Neighbours extension*
