# Sample survey report

## ANONYMISED EXAMPLE REPORT

A populated example of our Level 3 survey service.

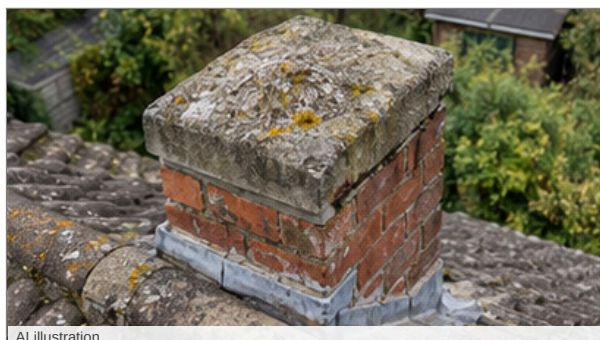
*Photo - 11 Rear-left chimney stack - drone view*

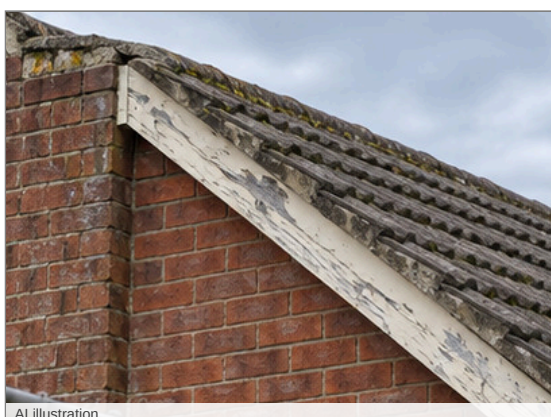
*Photo - 14 Rear left verge*

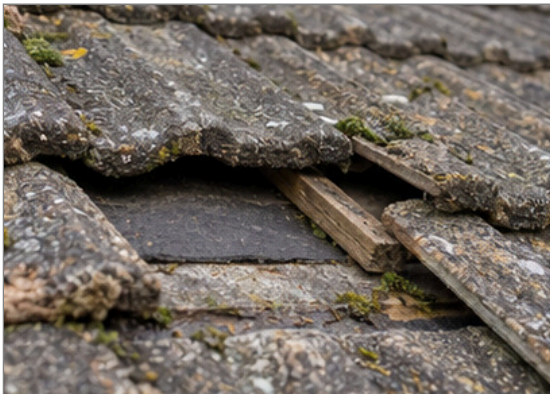
*Photo - 16 Lifted tiles*

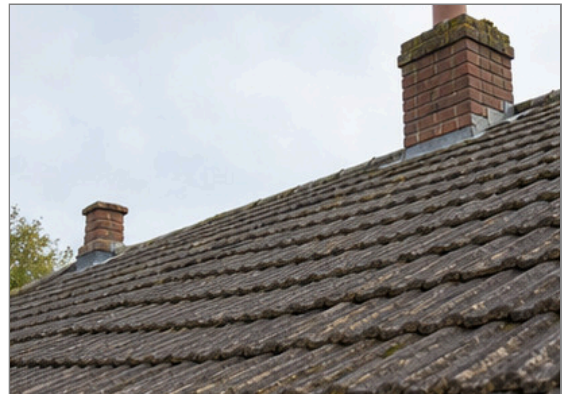
*Photo - 17 Uneven roof slope*

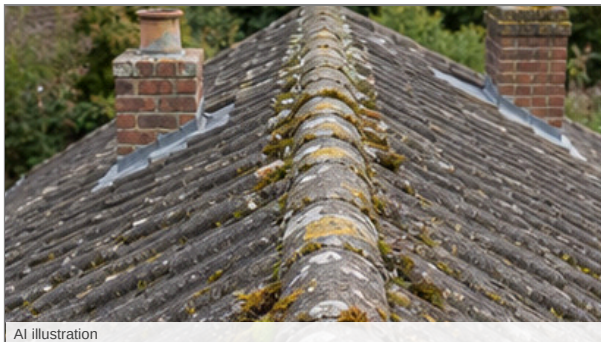
*Photo - 18 Weathered ridge - drone view*

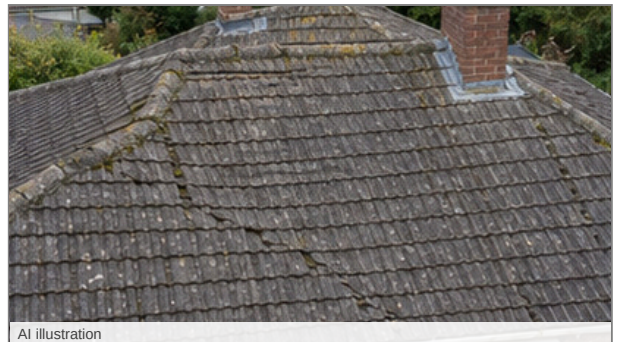
*Photo - 19 Uneven roof - drone view*

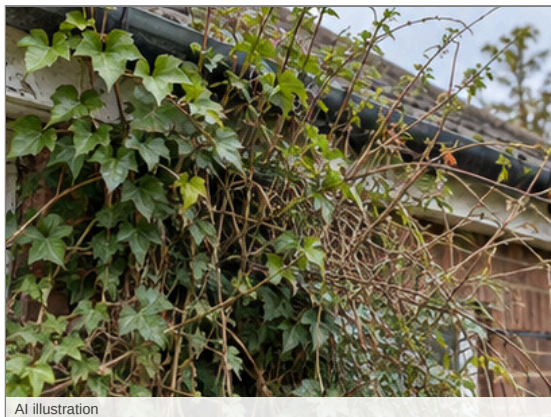
*Photo - 30 Plant growth*

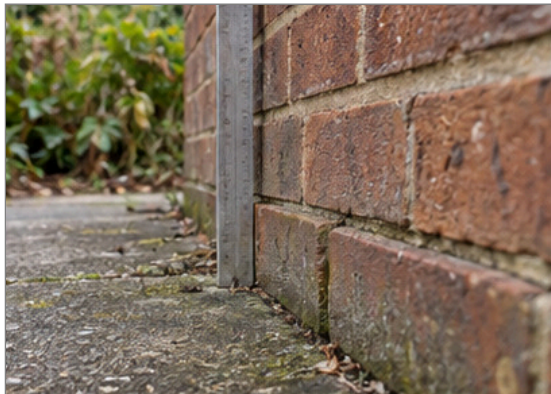
Of particular importance are the moderate deflection to the front and rear roof purlins, the outward movement identified to the lower rear elevation masonry, and the uncertainty regarding the rear-left chimney breast/flue arrangement, where the corresponding internal structure could not be clearly traced. These matters require further investigation, including structural advice where recommended, before legal commitment.

*Photo - 34 Rear elevation outward movement*

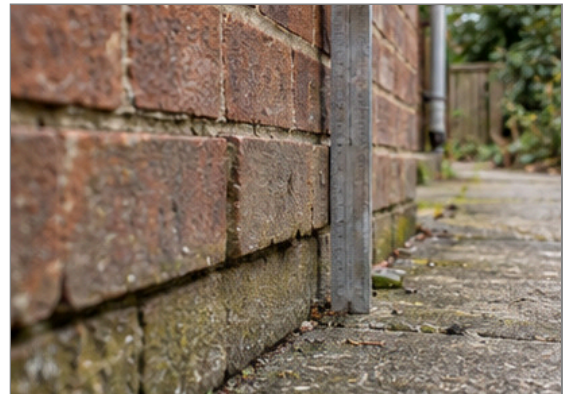
*Photo - 35 Further outward movement at the rear*

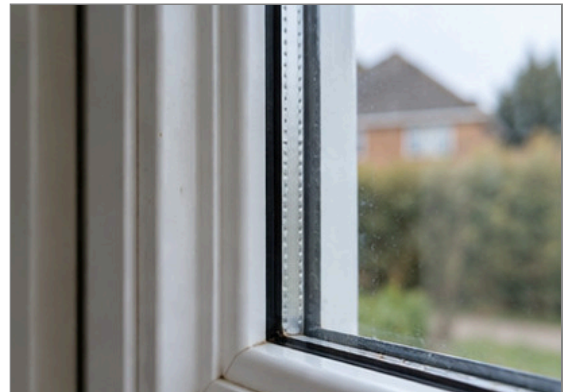
Photo - 43 Living room - no safety glass mark

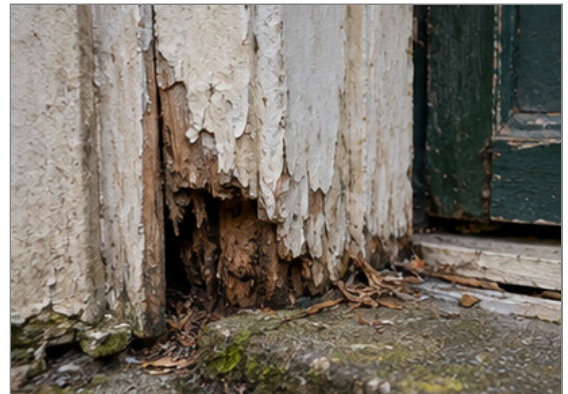
*Photo - 47 Rotten*

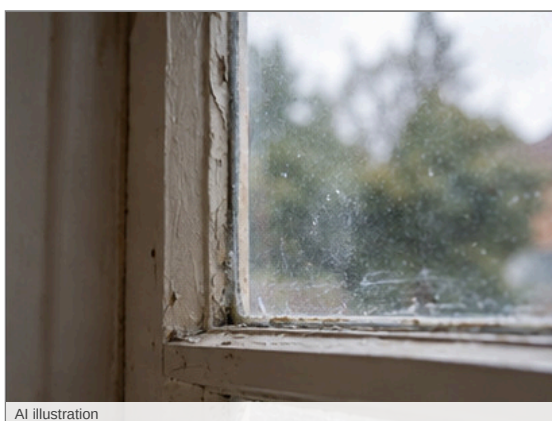
*Photo - 53 Single glazing*

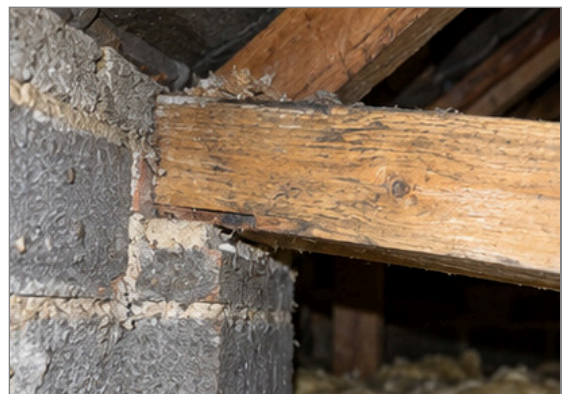
*Photo - 63 100mm bearing*

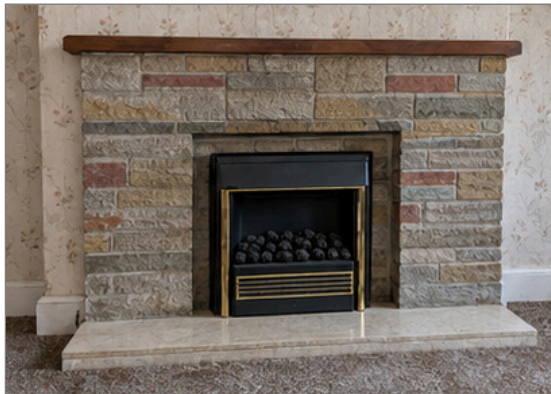
The fireplace and associated flue were not tested as part of our inspection. The fireplace flue opening has been only partially sealed, leaving gaps around the closure. This arrangement is poorly finished and may allow draughts, debris and moisture-related staining to enter the room from the redundant flue.

Photo - 78 Living room fireplace

Older chimneys and flues may not be suitable for modern appliances without repair, modification or relining. The chimney and flue should therefore be inspected and tested by a suitably qualified specialist, who can advise on the appropriate flue arrangement for the proposed appliance. Any necessary Building Regulations requirements should also be established before the works commence.

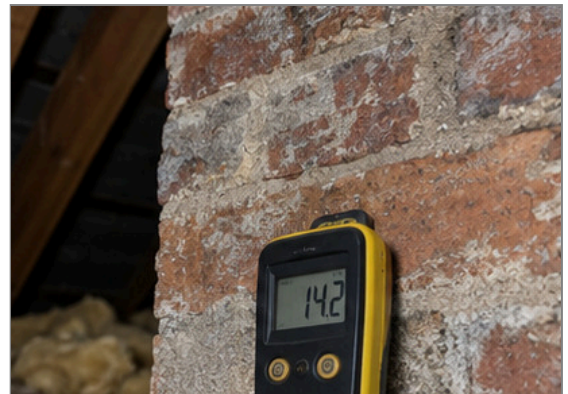
The accessible chimney masonry was tested using an electronic moisture meter where practicable. The readings were within the expected range for the materials tested.

Photo - 81 Low moisture reading

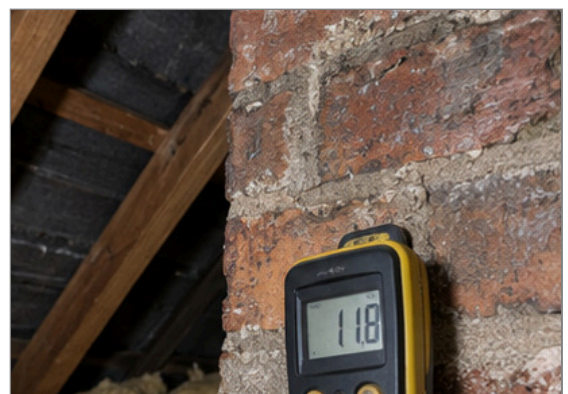
Photo - 83 Low moisture reading

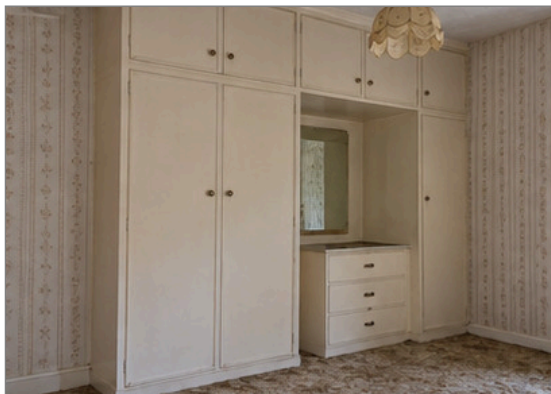
Built-in wardrobes are provided within all of the bedrooms. Although the fittings remain generally functional, they are dated and showing general deterioration.

*Photo - 85 Front right bedroom fittings*

The affected fittings should be maintained and repaired as necessary. Where replacement is required, you should obtain competitive quotations and allow for associated removal, disposal and making-good costs.

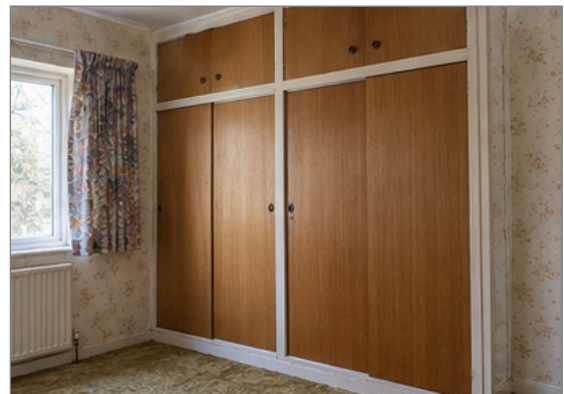
*Photo - 86 Front left bedroom fittings*

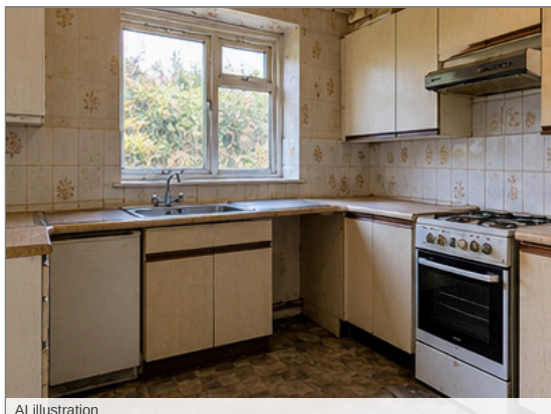
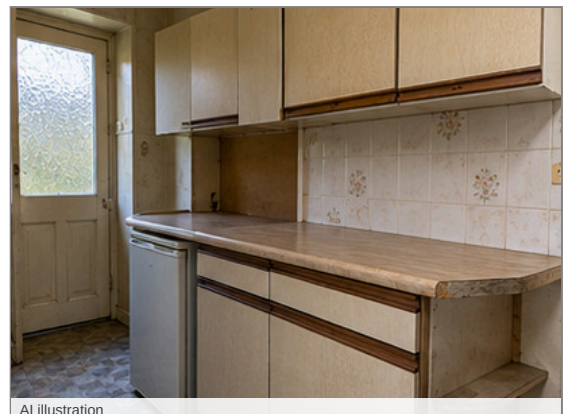
The existing fittings are significantly worn and dated. In our opinion, replacement of the fittings should be considered as part of the property's future refurbishment.

*Photo - 87 Kitchen*

You should obtain competitive quotations for the proposed replacement works before committing to the purchase and allow for associated costs including removal, disposal, plumbing, electrical alterations, worktops, flooring, wall finishes and making-good where applicable.

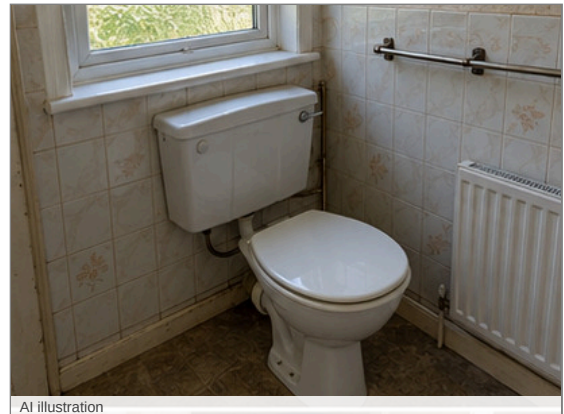
The sanitary fittings in the shower room comprise a shower with a glazed screen, a wash hand basin with a vanity unit and a toilet with a close-coupled cistern. The sanitary fittings appeared to be worn and showing general deterioration at the time of our inspection. We recommend the fittings be replaced once you take occupation.

Photo - 94 Shower room

Adequate ventilation is important in these areas to remove moisture generated by bathing and showering and to reduce the risk of condensation and mould growth. We recommend that suitable mechanical extract ventilation is installed, where practicable, to discharge moist air to the external environment. The ventilation should be appropriately designed, sized and installed in accordance with the manufacturer's requirements and applicable Building Regulations.

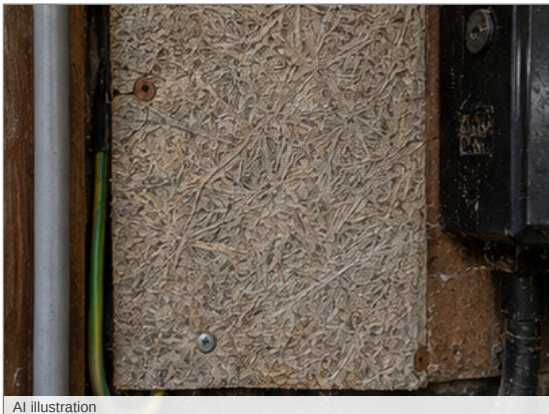
Some older electrical components and associated materials, including certain cable insulation, may contain asbestos-containing material (ACM). The presence or absence of asbestos cannot be confirmed by visual inspection alone.

Photo - 103 Potential asbestos containing material

The suspect materials should not be drilled, cut, sanded, removed or otherwise disturbed until their composition has been confirmed. Where electrical works may disturb the materials, appropriate sampling and testing should be undertaken by a suitably qualified asbestos professional, with the electrical works then carried out in accordance with the specialist's recommendations and applicable safety requirements.

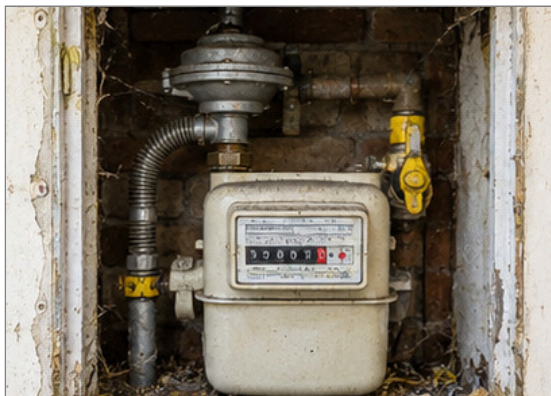
A current Gas Safety Certificate was not made available for review. You should obtain and review the relevant gas safety documentation and, where appropriate, arrange for the installation to be inspected by a suitably qualified Gas Safe registered engineer.

Photo - 104 Gas meter and shut off valve

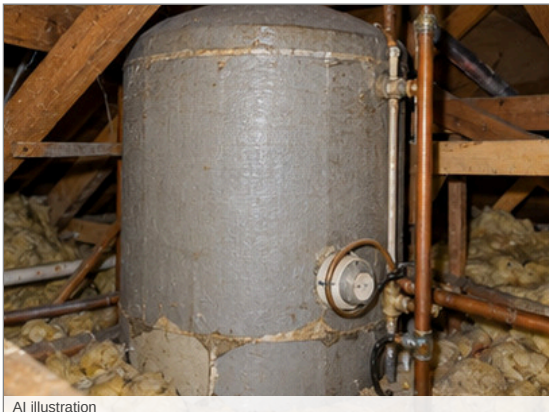
Photo - 120 Hot water cylinder

The cylinder and accessible associated pipework appeared to be in fair condition at the time of our inspection. The system was not subject to specialist testing.

You should obtain any available servicing, installation and maintenance records. The boiler, cylinder and associated hot water installation should be inspected and tested by suitably qualified Gas Safe specialists where greater assurance regarding condition, performance and safe operation is required.

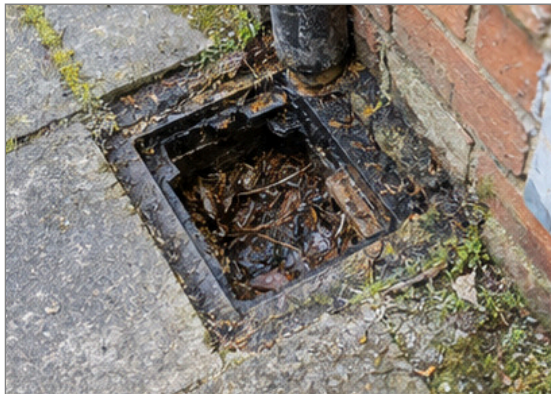
*Photo - 121 Left gully*

Defective or obstructed gullies can restrict surface-water drainage and may result in localised ponding or overflow. The affected gullies should be cleared of debris and fitted with suitable covers as appropriate.

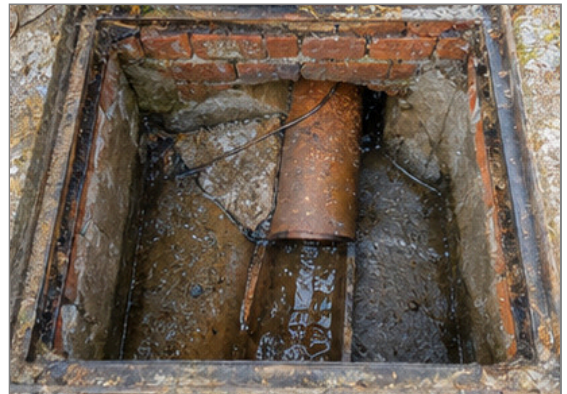
*Photo - 122 Left inspection chamber*

The inspection chamber was lifted as part of our inspection. The accessible drainage channels were generally partially silted, with no significant standing water noted at the time of our inspection.

The left-hand inspection chamber shows localised cracking/fracturing to the benching/channel surround adjacent to the drainage pipe. This may allow further deterioration of the chamber finish and could potentially affect the smooth passage of waste or permit leakage if the defect extends through the chamber construction.

The damaged area should be repaired by a suitable drainage contractor, with the chamber cleaned out and the fractured benching made good using an appropriate waterproof repair mortar. The chamber and adjoining drainage runs should also be checked at the time of repair for any further defects.

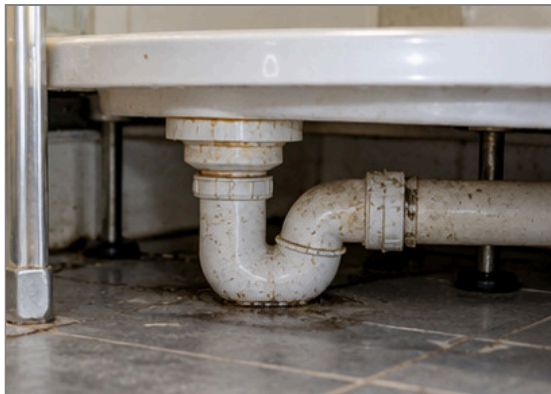
*Photo - 123 Shower room internal waste*

Where visible, the sanitary appliances within the property are connected to plastic waste pipes and traps. The external pipework was noted to be in worn condition.

A minor foul odour was noted within the shower room at the time of inspection. The source could not be confirmed. The property was unoccupied, which can allow water within traps to evaporate and permit drainage odours to enter the accommodation. We were also unable to establish the ventilation arrangement serving the foul drainage system.

The external pipework should be replaced when the corresponding fitting is renewed, as appropriate. The accessible internal waste pipework was noted to be in worn condition. The pipework should be replaced when the corresponding fitting is renewed, as appropriate.

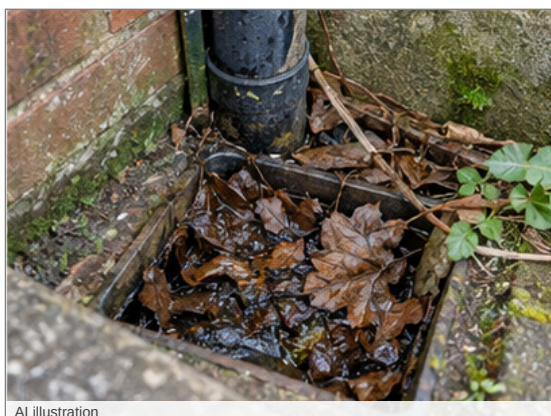
*Photo - 125 Rear left downpipe gully blocked*

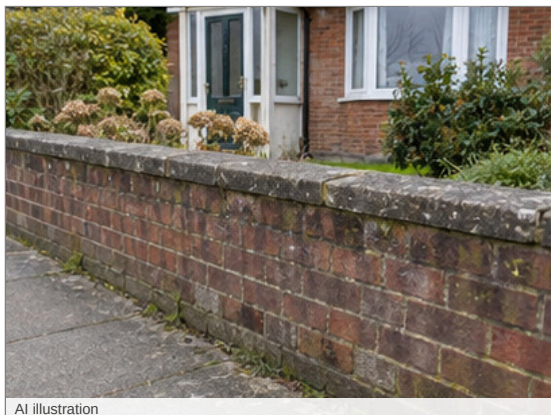
*Photo - 126 Front boundary*

The front boundary wall is of low-level masonry construction. Localised damage was noted, including loose and displaced masonry units adjacent to the entrance. The affected sections are unstable and may deteriorate further or become dislodged.

The loose masonry should be carefully dismantled and rebuilt, with defective bricks replaced as necessary and the joints repointed to provide a stable and durable finish. The remainder of the boundary wall should also be checked for any further loose or unstable sections at the time of repair.

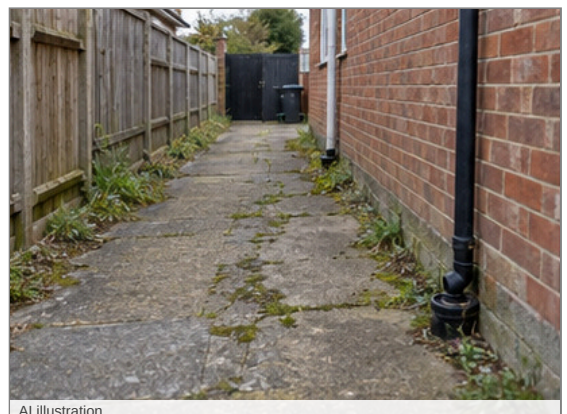
*Photo - 128 Paved driveway*

There is a section of paved driveway to the front of the property. The surface was uneven and weathered at the time of our inspection. The surface should be repaired, repointed and professionally cleaned within six months.

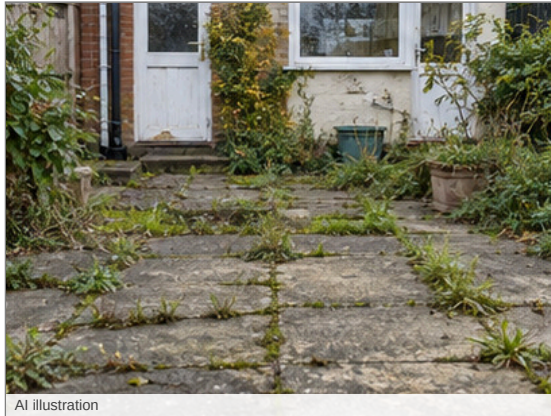
*Photo - 130 Rear patio*

There is a section of paved patio to the rear of the property. The surface was uneven and weathered at the time of our inspection. The surface should be repaired, repointed and professionally cleaned within six months.
